## REHABILITATION OF O'HARE INTERNATIONAL AIRPORT PARKING STRUCTURE

**Summary:** The primary parking structure serving O'Hare International Airport was opened for use in 1973 with 10,000 parking spaces and over 240,000 square meters of supported slabs. The six-story concrete structure was primarily reinforced using button-head post-tensioning. A condition assessment was performed in January of 2018 and identified structural deterioration which included freeze-thaw deterioration of concrete, corrosion-related delamination and spalling, and localized eruption of failed button-head tendons. Waterproofing deterioration consisted primarily of wear of waterproofing membranes and damage and wear of expansion joint seals. The resulting multi-year restoration program to extend the service life of the parking structure began in September 2020 and was completed in September 2022. Concrete and post-tensioning repairs to the slab, beams, girders, and columns were performed throughout. Sealant and expansion joint seal replacement were also performed to address leaks. Additionally, a unique structural strengthening repair was implemented at one of the columns that supports a signature helical ra

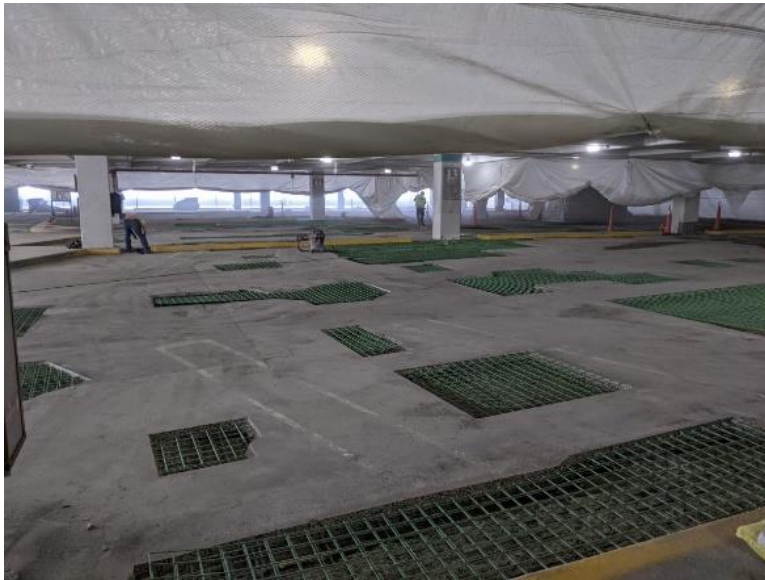
The supported floor systems had experienced delamination and spalling of the slab, beam, joist, and column surfaces at many locations throughout the structure due to exposure to deicing salts and water ingress. Additionally, all expansion joint seals in the garage had failed and numerous cracks were allowing moisture and deicing salts to enter the concrete. The moisture and deicing salts reached the level of the reinforcing steel, leading to corrosion of the embedded reinforcement and resulting in concrete delaminations.

*Figure 2: Full depth concrete repair openings in the work enclosure*

Repairs were implemented to address the concrete deterioration. The repair contractor removed the full depth of the 11.5 cm thick structural slab at areas of deterioration and performed partial depth removal at beams and vertical surfaces. Over 90,000 square meters of top surface/full depth repairs and 400 square meters of vertical and overhead repairs were performed. ACI and ICRI recommendations for best practices were followed for designing and implementing the repairs, including concrete removal around the full circumference of exposed reinforcing bars, coating of the exposed steel surfaces with a corrosion-inhibiting coating, providing new supplemental epoxy-coated reinforcement, and using replacement concrete designed to be more resistant to extreme weather exposure. Supplemental reinforcement was installed to address section loss of the existing reinforcement. An overview of one area of concrete repairs ready for concrete placement is shown in Figure 2.

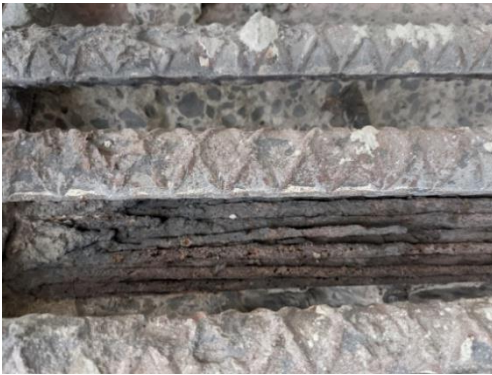
As the contractor performed concrete repairs throughout the garage, the engineer evaluated exposed tendons primarily in girders at repair openings, identifying tendons with various levels of corrosion-related wire loss (Figure 3). Structural analysis of the as-built configuration of the structure, including actual concrete strengths from material testing and the actual number of wires and tendons present, was used to quantify remaining structural capacity. As a result, the threshold

*Figure 3: Fractured and heavily corroded girder tendon exposed in a concrete repair opening*

for requiring tendon repair was refined, reducing the repair costs and expediting the repair schedule. Where tendon repairs were necessary, custom anchor plates were fabricated to allow restoration of the button-head system in-kind, reducing the amount of concrete removal required and avoiding the need for supplemental external PT systems. Replacement wire material exceeded the original specified strength, allowing the number of wires needed to be reduced. Four tendons were repaired with 50 meters of post-tensioning wire replaced. Sheathing restoration replaced the paper-wrapped sheathing with new waterproof sheathing materials to extend the life of the repaired tendons. Over 230 meters of sheathing repair was performed. After installation of the new tendons, the wires were stressed (Figure 4) and the surrounding concrete restored.

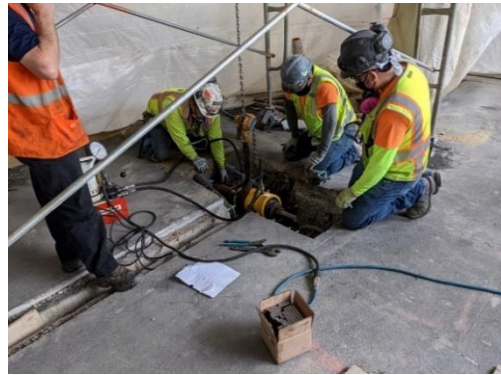
*Figure 4: Girder PT restressing*

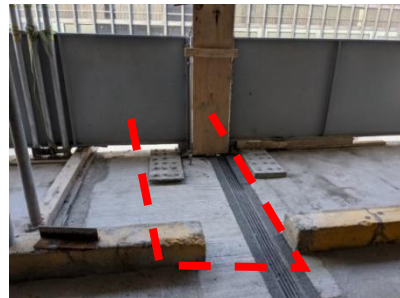
*Figure 6: Dropped infill block replaced with monolithic concrete (original position of infill block outlined)*

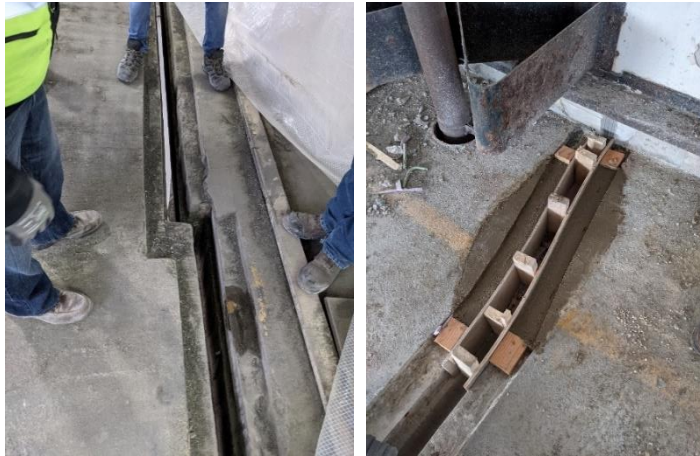
*Figure 7: Jog in expansion joint removed to allow for continuous joint seal installation*

At the ends of expansion joints, a 60 cm deep concrete infill block was used to allow access to stress the exterior girder post-tensioning during the original construction. The joint seal transitioned from a winged seal to a precompressed seal at this location, as the joint split in two directions around the infill block. A number of these concrete infill blocks were displacing downwards (Figure 5) and required immediate shoring until repairs could be performed. To repair the dropping infill blocks, reduce the length of joint seal required, and to eliminate a transition in joint seal type, the infill block was removed, and the joint opening reconfigured for a uniform-width joint seal (Figure 6). At other areas, jogs in the winged expansion joint from original construction had discontinuous joint seals that perpetually leaked. These jogs were reconfigured to allow for installation of a continuous joint seal, as shown in Figure 7.

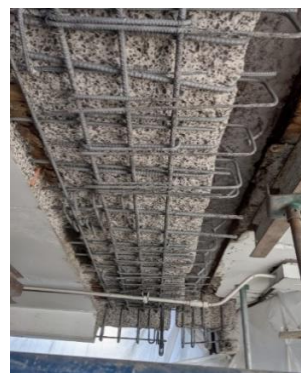
*Figure 9: Repair of deterioration of the underside of the ramp slab at the joint between the ramp and the parking deck*

Each pair of spiral ramps is essentially an independent structure, isolated from the garage (Figure 8). The ramps are constructed by cantilevering four levels of sloped floor slabs from six central columns. A bonded overlay was installed over the structural ramp slab during a previous repair project. The ramps receive heavy applications of deicing salts, and no traffic coating was present. Untreated cracks and debonded overlay allowed chloride and moisture exposure to the embedded reinforcement, leading to concrete deterioration, especially at the joint between the ramps and the parking deck (Figure 9). The deterioration at the joints required shoring of the slab during reconstruction of the joint where the bearing plate was cleaned and coated with corrosion-inhibiting coating and reinforcement with complete section loss was replaced with new epoxy-coated reinforcement. Over 1,100 square meters of concrete repairs on the top surface of the ramp slabs was performed with an additional 950 square meters of concrete repair on the underside of the ramps.

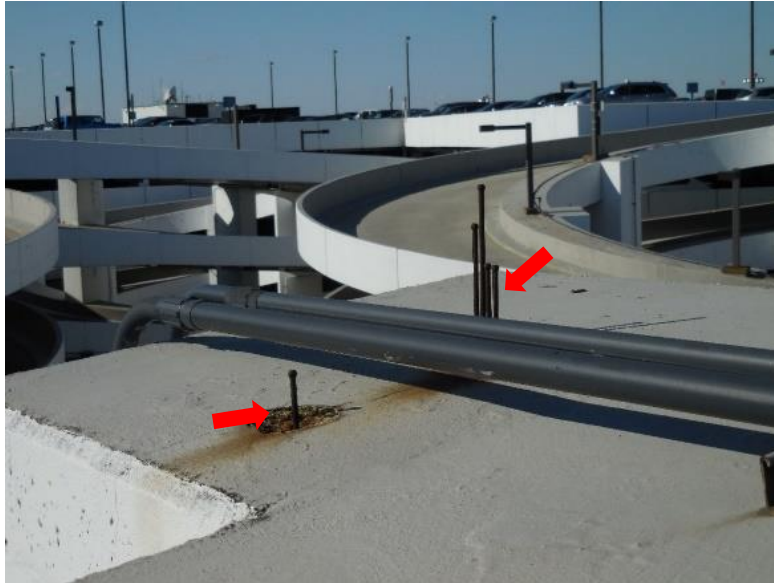
The 18.5 meters tall central columns are cantilevered from their foundations and are reinforced with three internal vertical button-head tendons, each consisting of 42-wires. The tendons resist the significant moment imposed on the column by the cantilevered ramp floors. During the initial condition assessment, 10 broken wires were observed protruding from the top of one column (Figure 10). Failure was caused by water intrusion at the stressing anchorage on the exposed top of the column. Considering the severe exposure conditions and high potential for further deterioration, the design team recommended that the column be strengthened to alleviate reliance on the original compromised post-tensioning for strength. This approach would prevent unexpected loss of use of a critical component of a heavily trafficked structure.

*Figure 10: Failed post-tensioning wires erupted from top of a helical ramp column*

The strengthening concept consisted of installing new vertical, draped, external post-tensioning (EPT) tendons on the subject column. The innovative detailing and implementation of the EPT alleviated the need to shore all of the supported floors of the ramp and avoided de-tensioning the existing tendons, thereby significantly reducing the schedule and cost, and utilized modern post-tensioning systems to elegantly provide a more resilient and robust structure.

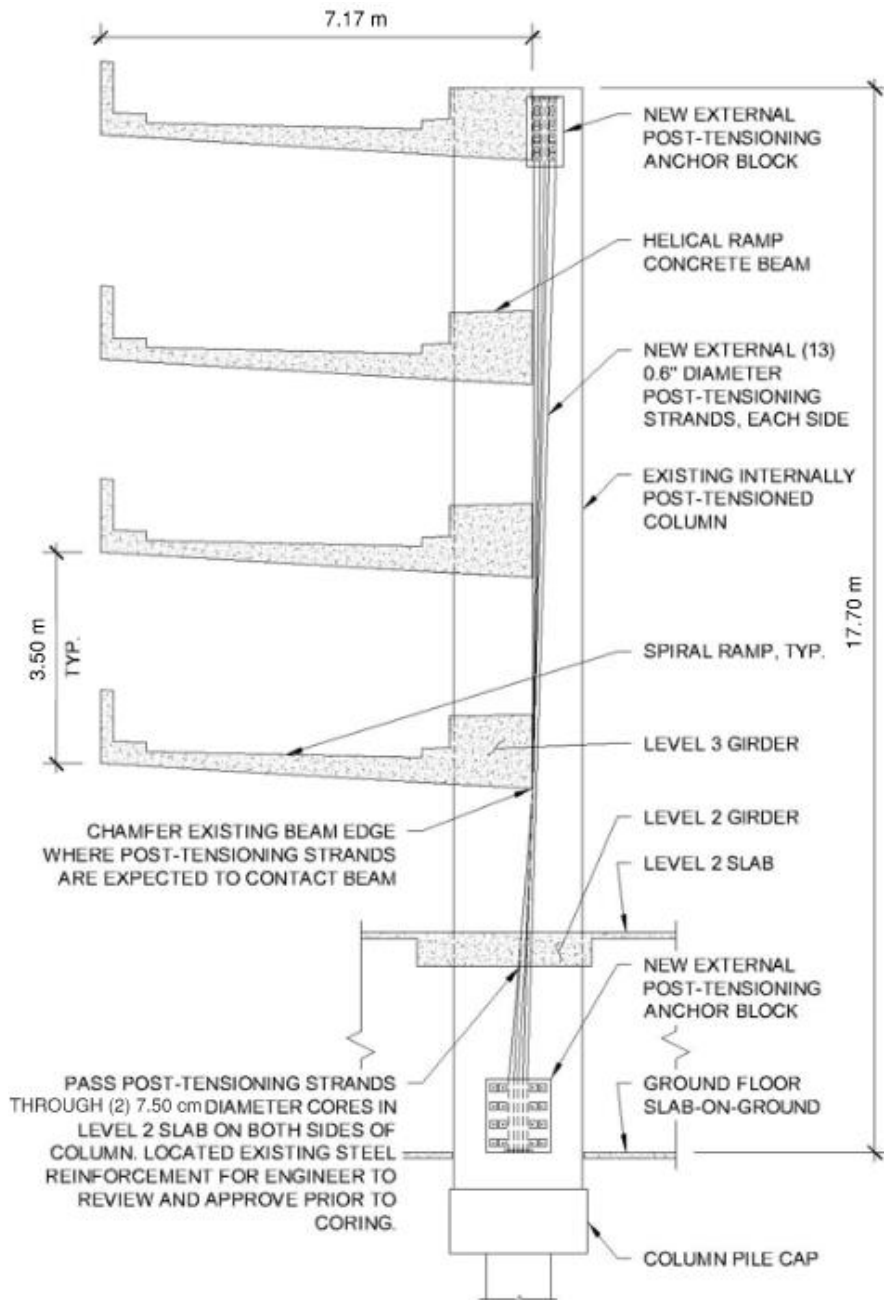
*Figure 11: Elevation of the vertical external post-tensioning strengthening of a cantilever column*

The EPT design and installation for the cantilevered column provided a unique engineering and construction challenge. The design intent was to replace the original post-tensioning design force, almost 455 tons in the 185 cm by 107 cm column, using new vertical EPT. The work had to be completed without access to the interior tendons or column foundation, and while accommodating limitations of the existing structure. EPT would replace the remaining existing post-tensioning system, which was inaccessible inside the column section, prohibiting further evaluation, repair, protection, or other direct intervention.

New vertical EPT tendons, each consisting of 13-15 mm diameter 7-wire strands, were mounted one per side to the long sides of the cantilevered column (Figure 11). The tendons were draped along the strong axis of the column to follow the drape of the original tendons. Each strand was stressed to 17,000 kg. New anchor blocks transfer all of the force from the new external tendons at the top (Figure 12) and bottom (Figure 13) of the column. The magnitude of force transfer required the use of 12-32 mm diameter, horizontal post-tensioned bars to clamp the

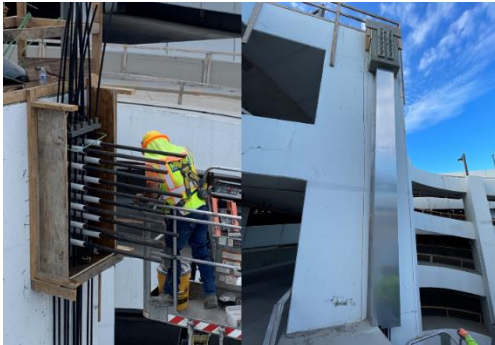
*Figure 12: One new anchor block for the vertical external post-tensioning system at the top of the column*

anchor blocks to the existing column. Each bar was stressed to 25 tons. The bars were anchored on each side of the column. The final position of the post-tensioned bars was determined in the field after GPR scanning of the columns faces was complete. The new bars had to avoid the original column tendons and conventional reinforcement, while the new EPT tendons had to avoid the girder tendons and conventional reinforcement where it passes through Level 2.

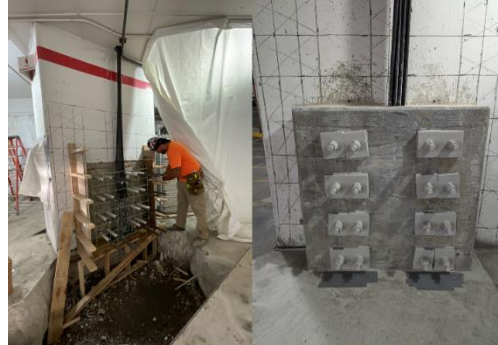
*Figure 13: One new anchor block for the vertical external post-tensioning system at the base of the column*

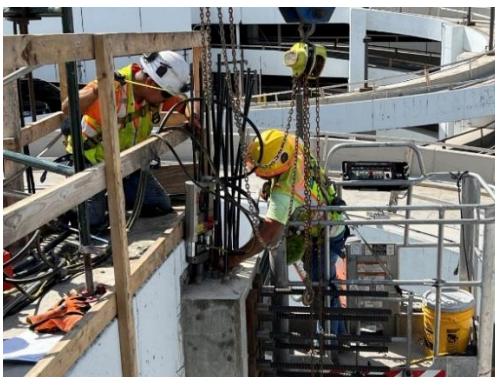
*Figure 14: Stressing of the vertical external post-tensioning tendons strengthening the cantilevered column*

Working at the top of the column to install and stress the vertical EPT and top anchor blocks presented an access challenge during construction. Instead of constructing an expensive work platform, the contractor constructed a barrier and established fall arrest anchorages at the top of the column. They were then able to efficiently perform the required operations by using an aerial lift and working from the top column surface (Figure 14). After stressing the new EPT tendons, the broken wires at the top of the column were removed, the openings sealed, and the top of the column protected with the application of a coating system. The exposed tendons were protected with stainless steel sheet metal covers against UV degradation. The finished EPT column repair is shown in Figure 15.

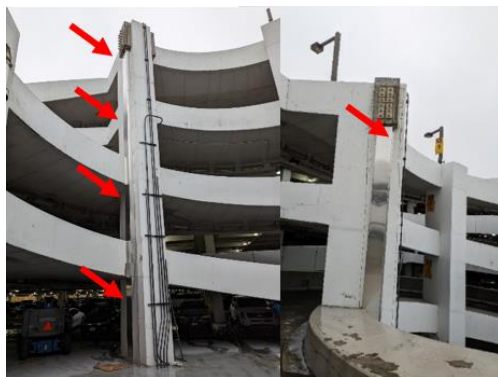
*Figure 15: Finished EPT column repair (red arrows) with stainless steel cover protection against UV degradation*
