## **STRUCTURAL ASSESSMENT AND RETROFITTING MEASURES FOR REINFORCED CONCRETE STADIUM STANDS**

**Summary:** This paper presents an assessment of the condition of the reinforced concrete structure of the stadium grandstands after many years of service and proposes recommendations to ensure its safe continued operation. The research focuses on deterioration of concrete and reinforcement in elements of the primary and secondary structural systems, including areas that were previously inaccessible for inspection during the facility's operation. New structural calculation models were developed to compare the obtained results with the values given in the original design documentation. Based on the analyses and inspections performed, recommendations are provided for eliminating the identified deficiencies and for establishing appropriate monitoring of the reinforced concrete structure during its future service life. After rehabilitation, the structure has remained in operation with continuous monitoring of its behavior and structural performance.

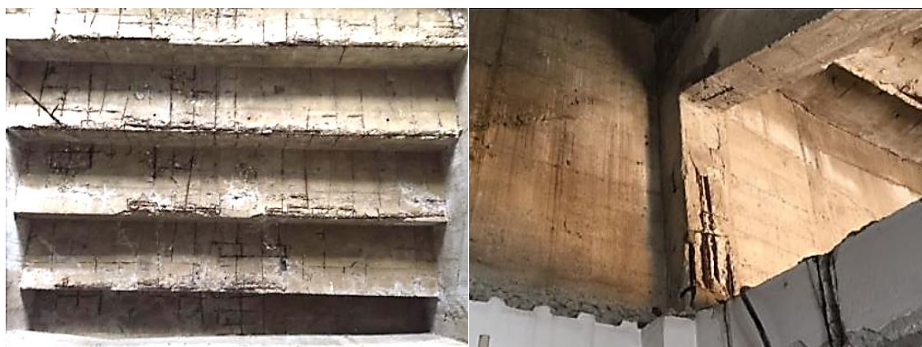
Significant portions of the load-bearing structure beneath the grandstands were found to have insufficient concrete cover, with both transverse and longitudinal reinforcement visibly exposed and undergoing active corrosion. Concrete spalling was also observed (Figures 3 and 4), most likely resulting from reinforcement corrosion and repeated freeze–thaw cycles.

*Figures 3 and 4: Damages to the reinforced concrete grandstand structure*

The extent of deterioration observed in the structural elements varied significantly. The reinforced concrete seat-support beams and reinforced concrete grandstand seating slabs exhibited both moderate and severe deterioration of the concrete and reinforcing steel, including complete rupture of reinforcing bars in certain cross-sections as a consequence of advanced corrosion. The columns, primary reinforced concrete beams, and reinforced concrete walls were characterized by moderate to minor deterioration of the same type.

The condition of the deteriorated concrete and corroded reinforcement required remedial intervention involving the removal of all damaged concrete and existing plaster finishes, followed

by the cleaning of reinforcement bars affected by corrosion. After thorough cleaning, the reinforcement of the structural elements was treated with a corrosion protection system. Subsequently, all reinforced concrete elements were restored to their original design geometry through the application of suitable repair mortars. In addition, the installation of a new waterproofing system for the beams and seating slabs of the grandstands was specified.

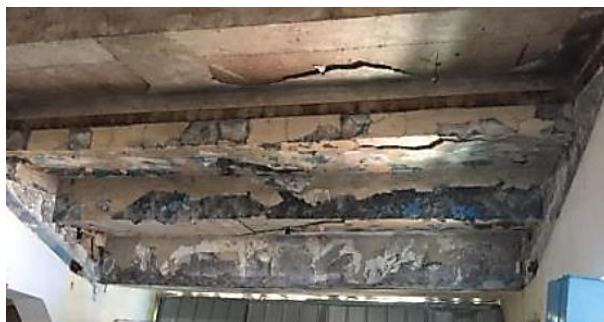
In addition to the detachment of the plaster finish applied to the reinforced concrete structural elements of the grandstands, traces of water infiltration indicated deterioration and the absence of an effective waterproofing system (Figure 5).

*Figure 5: Damage to the reinforced concrete grandstand structure*

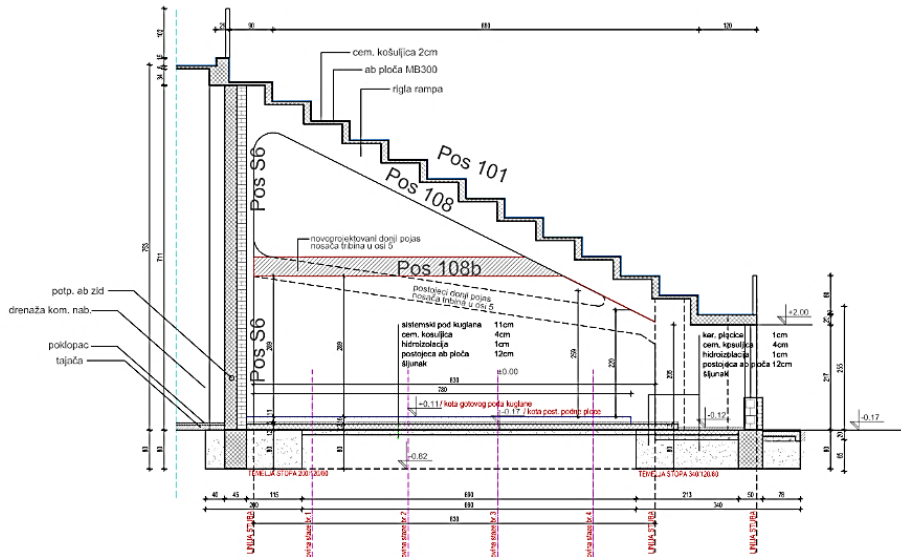
At the request of the occupant of the space beneath the grandstands (the bowling alley), a modification of the geometry of one of the beams within the transverse frame located along Axis 5 was also considered (Figure 7).

Figure 7: Modification of the geometry of the reinforced concrete beam within the transverse frame

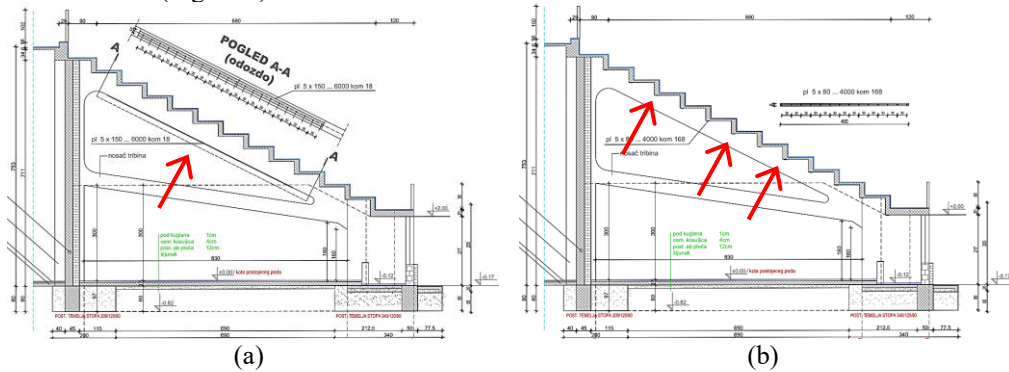
Figure 8: Strengthening of ramp stringers (a) and strengthening of seat-support beams of the grandstand (b)

The strengthening of the reinforced concrete structural elements was carried out using steel plates. In accordance with the results of the structural verification analysis, all beam elements were strengthened by applying steel strips only to the lower tension zone within the span (Figures 8a and 8b). Strengthening of the reinforced concrete retaining wall was performed by applying steel strips on the interior side of the sub-stand spaces, in the zones of maximum internal actions within the wall (Figure 9).

The arrangement and dimensions of the epoxy-bonded steel plates were defined to achieve the required enhancement of the flexural load-carrying capacity of the reinforced concrete members. Since the strengthening intervention for the beams and walls was designed to be implemented within a single region only, the ultimate limit state verification was conducted by applying a linear elastic analysis with limited redistribution of bending moments. Furthermore, the mechanical properties of the steel plates were selected to be consistent with those of the existing reinforcing steel, which represents a favorable condition regarding the structural compatibility of the strengthened members. The improvement in the flexural resistance of the reinforced concrete members achieved through the application of epoxy-bonded steel plates also contributed positively to the serviceability limit state verification. The calculated stress levels,

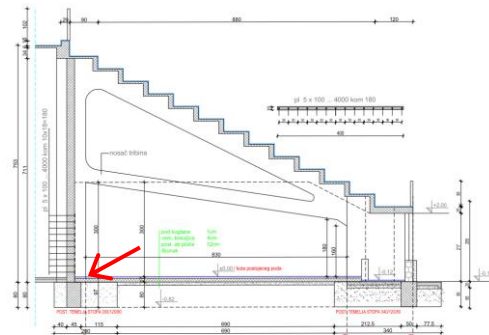
Figure 9: Strengthening of the reinforced concrete retaining wall

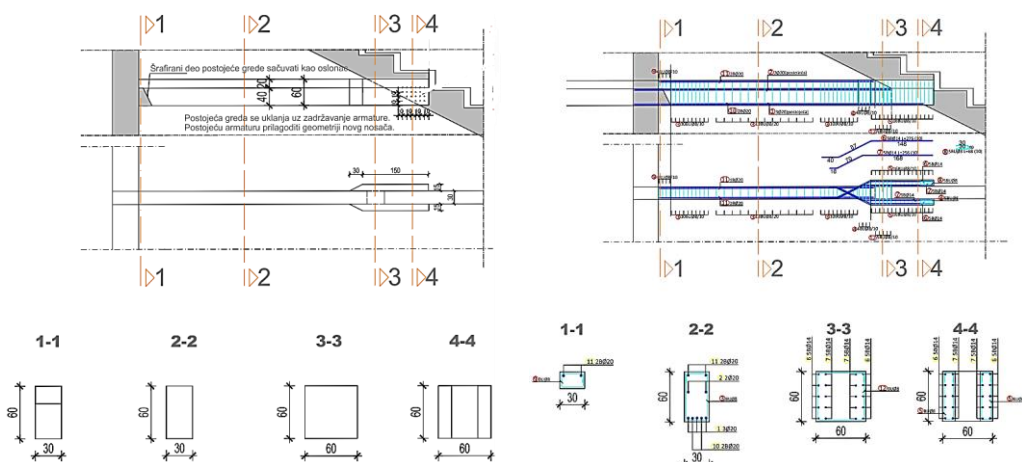
Figure 10: New beam of a transverse frame

Reconstruction works on the grandstands also included a modification of the geometry of one transverse frame. The lower inclined beam of the frame was removed and subsequently replaced with a horizontal beam. This intervention was carried out at the request of the user of the sub-stand space in order to increase the clear height in this area.

The procedure involved the removal of concrete from the existing beam while retaining the existing reinforcement and a portion of the concrete in the region of one support, in order to ensure a rigid connection. The new beam was constructed by adapting the configuration of the existing reinforcement bars, supplemented with additional reinforcement where required, followed by concreting (Figure 10).
