## THE COLLAPSE OF THE CAROLABRIDGE – A TRAGIC INDIVIDUAL CASE?

**Summary:** The majority of small and medium-span bridges in Germany are made of prestressed concrete. All bridges are inspected at regular intervals to identify damage or load-bearing deficiencies at an early stage. Nevertheless, on September 11, 2024, the prestressed Carola Bridge in Dresden partially collapsed without prior warning. This article first provides an overview of the bridge inventory in Germany and the normative regulations governing their monitoring. It then presents the special design of the Carola Bridge and its construction. The main part focusses on the search for the causes of the failure and an attempt to reconstruct the sequence of events leading to the collapse. The article concludes with an outlook on issues relating to the future handling of bridges containing prestressing steel that is susceptible to hydrogen induced stress corrosion cracking (SCC).

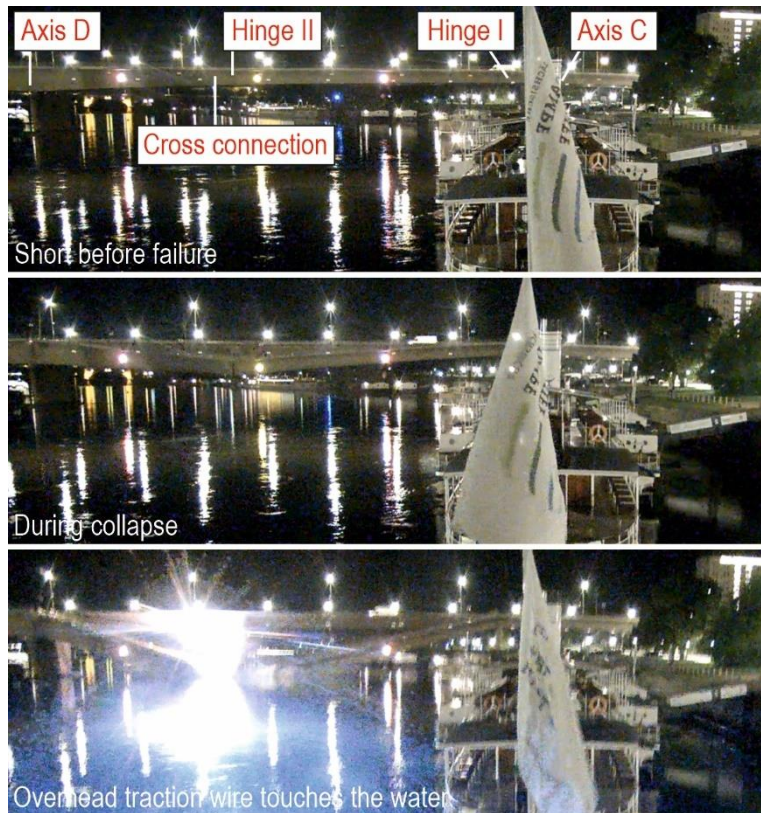
dramatic event (Figure 2). Looking upstream, it captured exactly the critical area between axes C and D. A frame-by-frame analysis showed the collapse process: first, the area of hinge II began to sink, while a crack opened up at the support cross-section of axis D. Shortly thereafter, the contact wire came into contact with the water. A flash of lightning illuminated the darkness, accompanied by a spraying fountain. Only about eight minutes before the failure, a tram had rolled over this very bridge and most likely initiated the kinematic chain. Fortunately, there were no pedestrians or cyclists on the structure at the time of the collapse.

*Figure 2: Recordings from a surveillance camera: initial state and moment of collapse (video from Saxon Steamship Company,[18])*

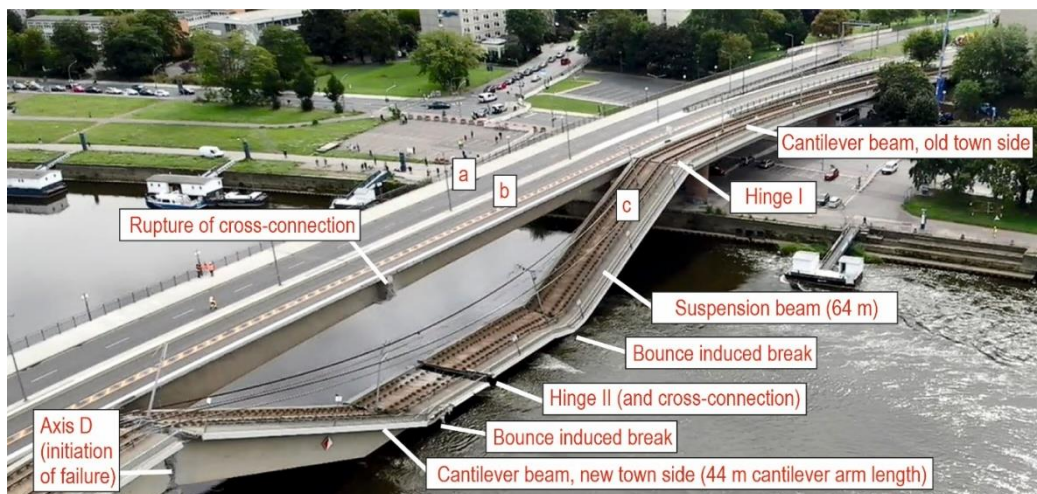
At daylight, the extent of the damage became apparent (Figure 3). A state of emergency had already been declared, and the City of Dresden, the fire department, the Federal Agency for Technical Relief (THW), the police, and the German Armed Forces set up a crisis management team at the abutment on the old town side. The responsible road and civil engineering office convened a group of experts who first assessed the acute stability of the still standing superstructures a and b. A look at the torn-open cross-section in axis D of superstructure c immediately provided clues as to the cause of the damage. Just a few hours after the accident, technical documentation of the damage began – initially using drones, and later with photographs taken from the neighboring superstructure b.

Figure 3: Carola Bridge immediately after the collapse of superstructure c (© MKP GmbH, [16][16, mod.]

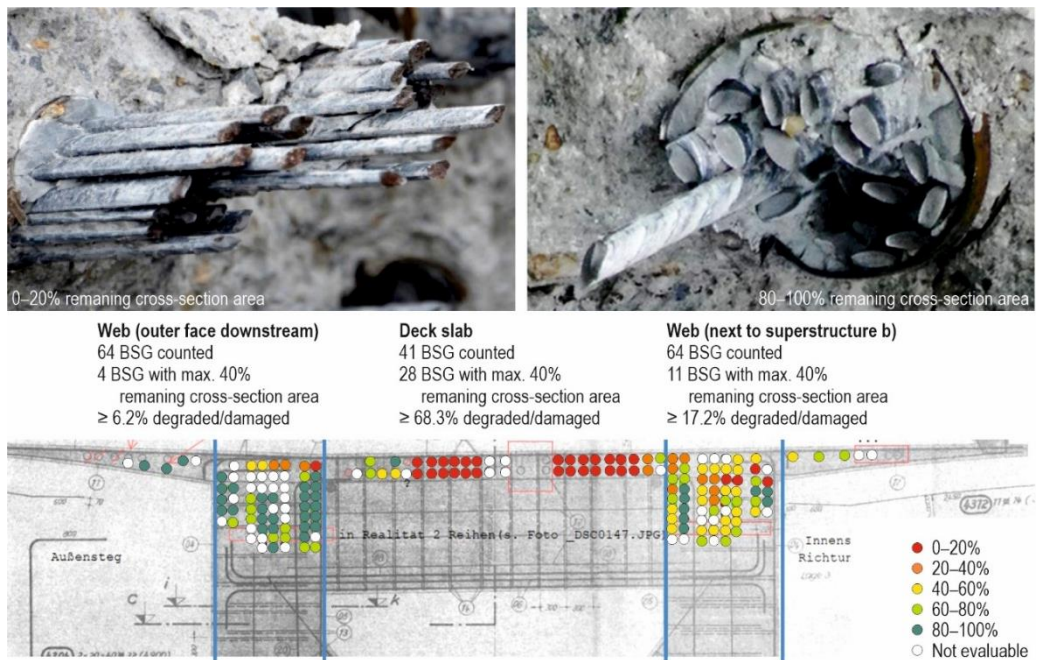
The condition of the prestressed wires was visually assessed and categorized. It was clearly visible that the deck slab tendons, which remained partially tensioned in the ducts during manufacturing of the suspension beams (see chapter 2), showed particularly severe pre-damage and dark corrosion on the fracture surfaces (top left photo in Figure 4). Obviously, these wires had been broken for quite some time. Fresh fracture surfaces (top right photo in Figure 4), mainly on web tendons, were metallically shiny with no signs of corrosion, but also without any ductile deformation in the form of necking in the fracture area. In some cases, tendons with visible necking were also found, indicating ductile failure.

Figure 4: Results of photographic documentation of the condition of the prestressing wires, broken cross-section in axis D, superstructure c, view towards Dresden new town (© MKP GmbH,[16], [19])

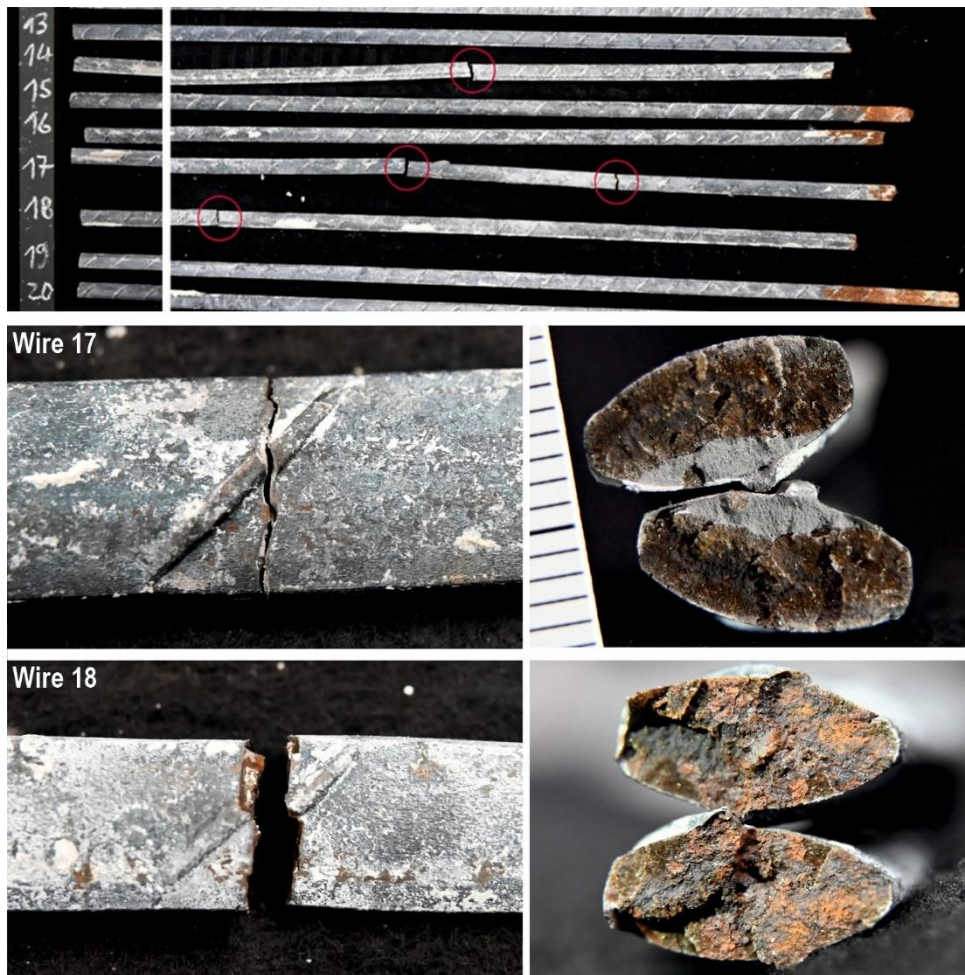
The samples obtained were first documented photographically in the laboratory and then subjected to further material tests. In some of the tendon sections taken from the area of the fracture, wire breaks were already detected when the tendon was opened (Figure 5, top). In some cases, cracks were even visible to the naked eye. Many fracture surfaces showed clear signs of corrosion (wires 17 and 18 in Figure 5). It should also be noted that prestressing wires with multiple fractures and a distance of less than 15 cm were found (see wire 17 in Figure 5). This indicates an immediate re-anchoring length of a few centimeters after a break.

*Figure 5: Breaks of wires from a tendon extracted from the failure area in axis D of superstructure c (top) and details of the breaks of the wire 17 and 18 (below) (photos: MKP GmbH,[18])*

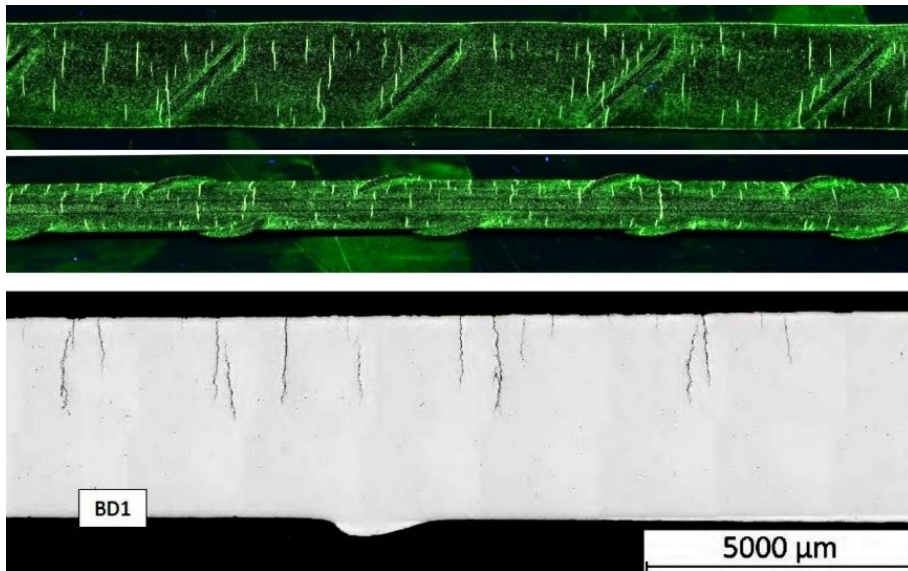
For further analysis, crack detection tests with magnetic powder, microscopic examinations of the fracture surfaces, microstructural examinations and examinations of the alloy composition carried out at the Federal Institute for Materials Research and Testing (Bundesanstalt für Materialforschung und -prüfung – BAM), Berlin. Magnetic particle inspection (MPI) tests, cracks or material defects on the surface or close to it can be made visible under UV light using fluorescent magnetic powder particles. The top photo in Figure 6 shows a prestressing wire during MOI investigation with a large number of initial cracks, which can be clearly attributed to SCC. Figure 6 below shows a longitudinal section of a prestressing wire where the typical cracks are also clearly visible.

Figure 6: Initial crack detection using fluorescent magnetic powder (top) and longitudinal sectioning (bottom) of two prestressing wires taken from the Carola Bridge (photos: BAM Berlin, [16])

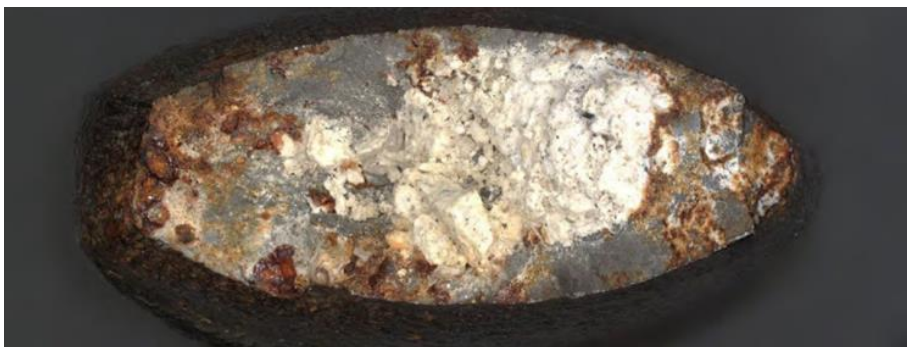
On the post-tensioned tendons in the deck slab in axis D, superstructure c, almost black fracture surfaces were detected on many of the prestressing wires (top left photo in **Error! Reference source not found.** 4). This type of corrosion had already been detected at a bridge that had been constructed using the tension block method [20]. It was therefore known that such oxide layers develop on fracture surfaces that were still exposed to a sufficiently high humidity but not to a high oxygen content. For the time being, however, it remained unclear why only a defined group of prestressing wires exhibited this damage pattern. No significant corrosion damage and in particular no perforation corrosion could be detected locally in the associated ducts. Interaction with penetrating media during operation of the bridge could therefore be ruled out, and also stray current corrosion for the same reason. The most likely assumption is that the prestressing wire fractures most probably occurred during construction or shortly afterwards, but, in any case, a long time ago. During later microscopic examinations of broken wires, mortar adhesions were found on some of the failure surfaces (**Error! Reference source not found.**ure 7), which are a clear indication that these breaks must have occurred before or during grouting.

Figure 7: Wire break with mortar at the fracture surface (photo: BAM Berlin, [19])
