## OPERATION AND MAINTENANCE OF BRIDGE DRAINAGE SYSTEMS ALONG THE SAVA RIVER IN BELGRADE

**Summary:** This paper assesses the operational performance of drainage systems on four road bridges over the Sava River in Belgrade: Branko's, Gazela, Ada Ciganlija, and Ostružnica. Field inspections identified deficiencies related to original design, subsequent modifications, ageing drainage infrastructure, structural and pavement deformations, and inadequate maintenance, all of which can significantly reduce drainage effectiveness. Particular attention is given to the Gazela Bridge, where hydraulic analysis showed that an average structural deflection of 14 cm reduces flow velocities in drainage pipes by about 10% for the 10-year design storm, increasing the potential for sediment deposition and pipe blockage. The four cases demonstrate that drainage functionality can be compromised at different stages of the bridge life cycle. The paper highlights the need for continuous inspection of structural and drainage components and performance-based maintenance.

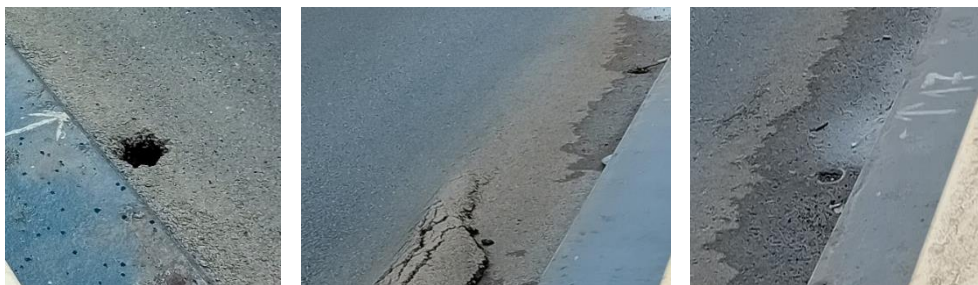
Branko's Bridge has a drainage system with an unsatisfactory level of performance. Surface runoff is collected through a series of relatively small openings within the bridge structure, each with a diameter of 12 cm (Figure 2). However, long-term pavement deterioration, including rutting, potholes, localized depressions, and surface irregularities, significantly impedes runoff concentration toward the curbs and the drainage inlets. As a result, water accumulates and spreads over the pavement during intense rainfall and is splashed by passing vehicles, adversely affecting traffic safety and driving conditions. An additional problem is its relatively small cross slope, which prevents part of the runoff from being effectively directed toward the drainage openings.

*Figure 2: Drainage openings in the structure of the Branko's bridge and pavement deformations prevent effective drainage even during relatively moderate rainfall events*

The unrestricted discharge of runoff through the openings is therefore highly inefficient. Furthermore, based on the authors' experience with the Gazela Bridge, it can reasonably be assumed that this drainage practice contributes to corrosion and deterioration of the underside of the bridge structure. It can therefore be concluded that detailed inspections and comprehensive rehabilitation of the bridge drainage system are required.

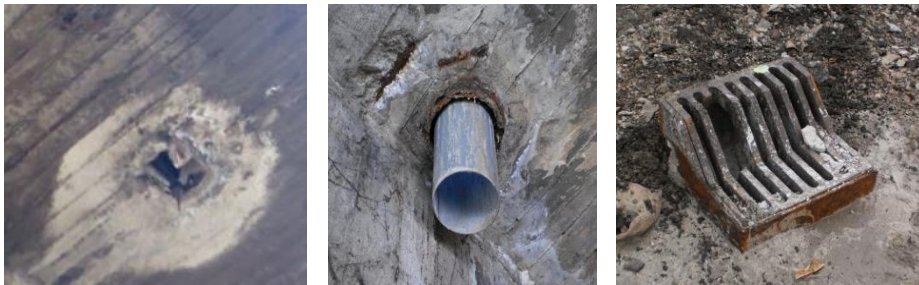
The Gazela Bridge is the only bridge across the Sava River in Belgrade where an integrated runoff collection and treatment system was implemented during the bridge rehabilitation between 2010 and 2012 [13]. Prior to rehabilitation, the bridge experienced numerous problems associated with uncontrolled stormwater discharge, deterioration of drainage components, and progressive degradation of structural elements caused by water and the dissolved aggressive substances. Figure 3 (left and centre) illustrates the condition of the underside of the bridge deck near the drainage outlets before rehabilitation, while Figure 3 (right) shows a curb inlet grate on the bridge deck. Uncontrolled runoff carrying pollutants are washed from the pavement (including oils, grease, and de-icing chemicals) and flow over the bridge structure, contributing to corrosion and deterioration of its steel elements (Figure 4).

*Figure 3: Components of the Gazela Bridge drainage system (drainage openings, outlets, and inlet grates) prior to the 2012 rehabilitation*

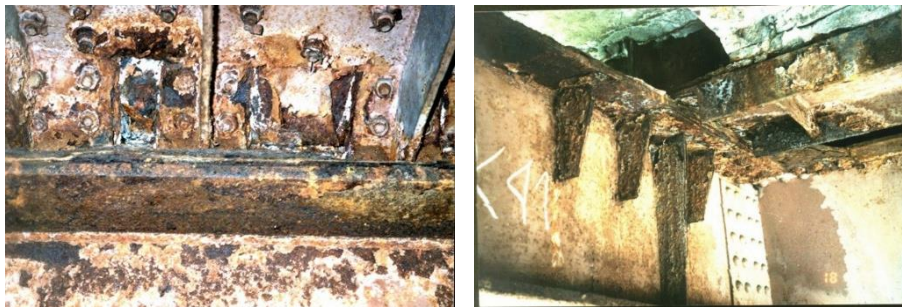
*Figure 4: Condition of the Gazela Bridge structure resulting from corrosion of the steel box girders prior to the 2012 rehabilitation*

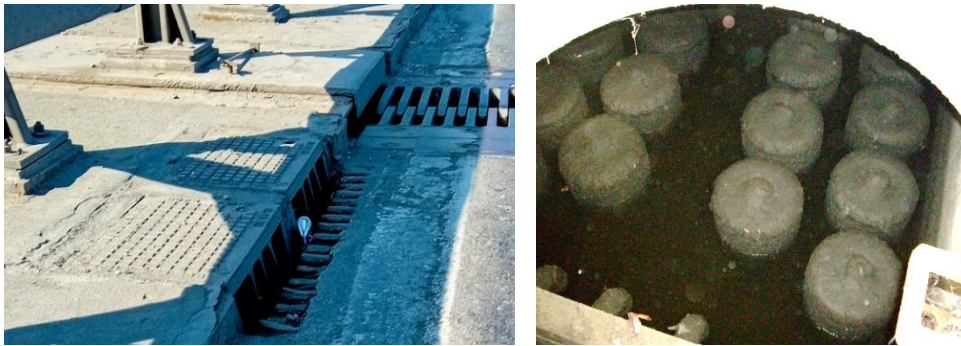
However, operational experience has shown that even modern drainage systems require continuous maintenance. More than a decade of service upon the rehabilitation, drainage inlets and expansion joints are subject to deformation, while sediment accumulation within the treatment filters has reduced their hydraulic capacity and treatment efficiency (Figure 5).

*Figure 5: Gazela Bridge 12 years after the rehabilitation: deformed drainage inlets and expansion joints (left); sediment-clogged filters in the stormwater treatment facility (right)*

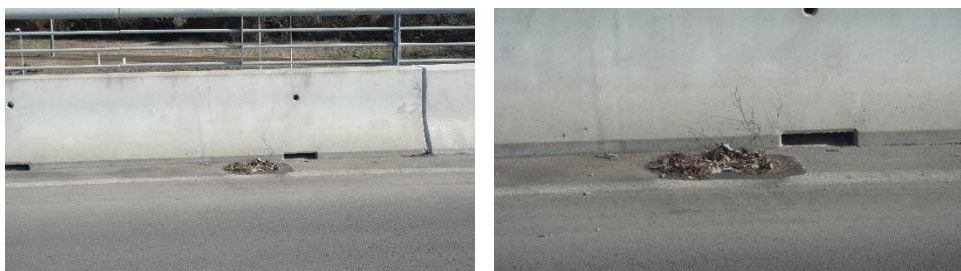
Immediately before the bridge was opened to traffic, modifications were introduced that were not compatible with the originally designed drainage system. Specifically, New Jersey concrete barriers were installed to improve traffic safety. However, this intervention left the drainage inlets on the opposite side of the barriers from several traffic lanes, preventing runoff from those lanes from reaching the inlets. Consequently, the drainage system is unable to collect runoff from the full width of the bridge deck as originally intended. Moreover, even the remaining functional inlets have not been adequately maintained, further reducing the overall efficiency of the drainage system (Figure 6).

*Figure 6: Unmaintained drainage inlets on the Ada Ciganlija bridge*

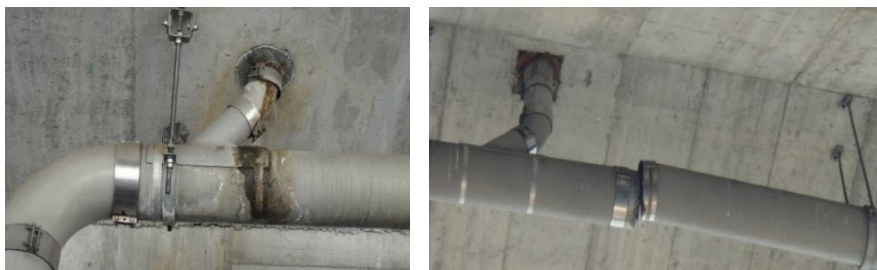
During operation, additional deficiencies have been observed in several components of the drainage system, particularly the pipes, pipe connections, clamps, and anchor supports (Figure 7). These problems may be attributed, at least in part, to insufficient care in the procurement, quality control and installation of drainage system components, including drainage inlets, pipes, pipe supports, and associated fittings. As a result, the quality and long-term performance of the installed components were not adequately verified. These observations highlight the importance of rigorous supplier selection, quality assurance during procurement and construction, and regular inspection and maintenance of the entire drainage system throughout its service life.

*Figure 7: Unsatisfactory condition of drainage system components on the underside of the Ada Ciganlija Bridge structure*

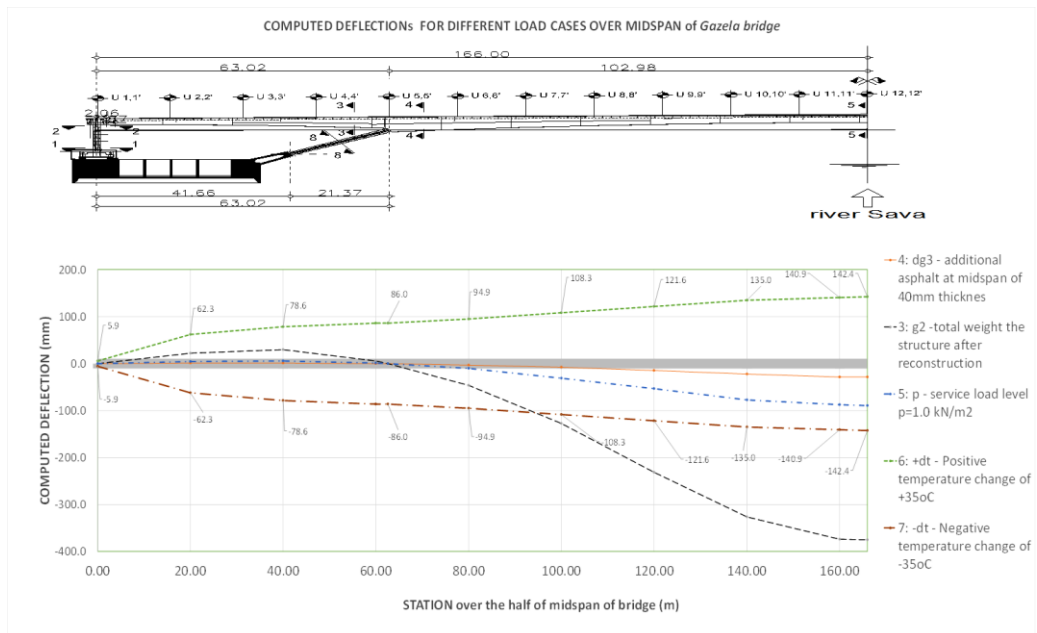
The drainage pipes undergo the same deformations as the bridge structure as they were installed parallel to the edge of the bridge deck to satisfy aesthetic requirements. This reduces the pipeline gradient, particularly near the crown of the central span where it is already relatively small, possibly decreasing below the minimum required for self-cleansing flow conditions. Hydraulic analyses for a 10-year return period design storm [14] showed that the average bridge deflection of 14 cm reduces flow velocities in the drainage pipes by approximately 10%. This can impair sediment transport and promote progressive sediment deposition, reduce hydraulic capacity and increase the risk of pipe blockage.

Field inspections have also shown that structural deformations increase maintenance requirements and can significantly impair the long-term performance of bridge drainage systems [14]. Inlets located near the bridge crown are particularly susceptible to clogging and mechanical damage. When the inlets are unable to collect runoff at their full design capacity, flow velocities in the downstream pipes may fall below self-cleansing levels, leading to sediment deposition and pipe blockage. These processes further reduce system performance and increase maintenance

Figure 8: Deflections of the left half of the Gazela Bridge obtained from a structural model developed on the basis of field measurements [14]

demands. These problems can be mitigated through regular inspections and, where necessary, high-pressure cleaning of inlets and pipes. Pipes in critical sections may be mounted on rollers or other flexible supports to accommodate bridge deflections to a certain extent [15].
