### **FULL REPLACEMENT OF STAY CABLE SYSTEM: STATE OF THE ART PRACTICES, DEDICATED METHODS, MODERN SYSTEM INTEGRATION, AND RISK MITIGATION**

**Summary:** As many cable stayed bridges built in the 1960s reach the end of their original service life, replacing aging stay cable systems has become a major challenge for infrastructure owners. Corrosion, obsolete protection systems, and modern durability requirements drive the need to upgrade these structures with high performance cables. Freyssinet has developed strong expertise in this field, combining advanced engineering, dedicated equipment, and rigorous risk management. This paper presents Freyssinet's approach through recent projects such as the Hooghly River Bridge, the Galecopper Bridge, and the Marqués de Zafra footbridge. These cases highlight two main challenges: integrating modern cable systems into structures designed for older technologies, and safely managing detensioning operations despite uncertainties about existing cable conditions. Freyssinet addressed these issues by engineering tailored solutions, including redundancy systems, controlled detensioning methods, and the installation of durable, replaceable parallel st

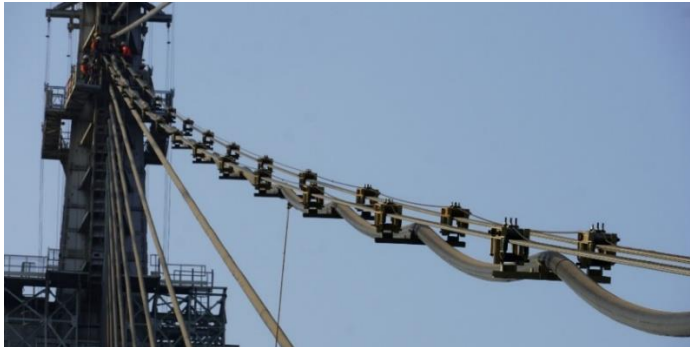
Once fully detensioned, the existing cable is removed using an innovative lowering system based on rollers running directly on the temporary stay. This eliminates the need for additional highline systems and simplifies operations significantly. The cable is then lowered using a deck-mounted winch, enabling full removal in less than one day, even for long and heavy stays. The entire methodology is designed for repetition and reuse, allowing efficient execution across all 152 cables, if deemed necessary after the initial inspection campaign.

*Figure 2: Detensioned cable being lowered on the temporary cables with roller assemblies*

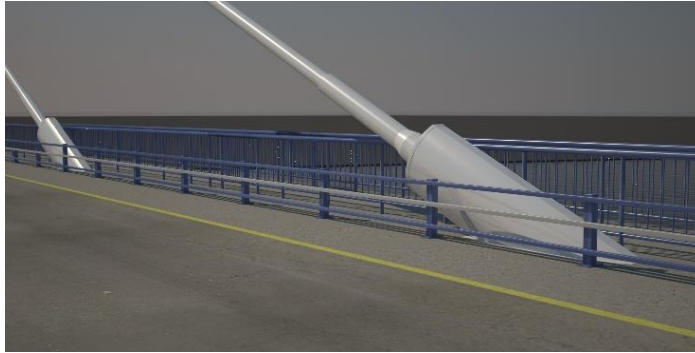
- High fatigue resistance anchorage with reversible watertightness design,
- High performance viscous dampers,
- Fire protection for a 1100°C load case and a 60 minute rating up to a height of 10m above deck level and including a full encapsulation of the anchorage area above the deck.

*Figure 3: Cable fire encapsulation at deck anchorage*

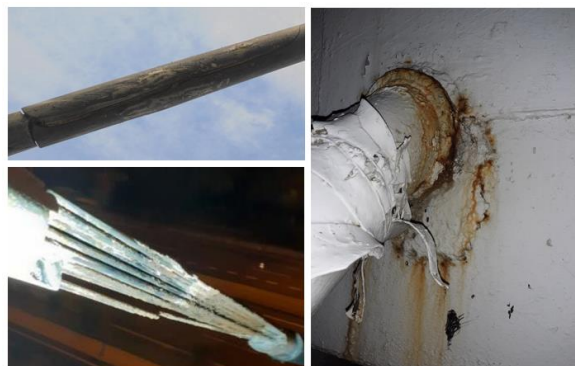
The cable system included inclined stays supporting the main span, vertical stays aligned with the pylons, and backstays connected to the side spans and anchored to abutments through tiedown cables. While this configuration ensured global equilibrium, it relied on a relatively low level of redundancy and on protective systems typical of the 1970s. Inspections performed in 2020 highlighted significant durability issues, including water ingress, lack of watertightness at the upper anchorages, internal voids in grout, and active corrosion of steel wires. In extreme cases, cross-sectional losses approaching 30% were observed in critical cables, raising concerns regarding structural safety and long-term performance. These findings led to the decision to replace the entire stay cable system.

*Figure 4: PWS cable recorded during inspection stage*

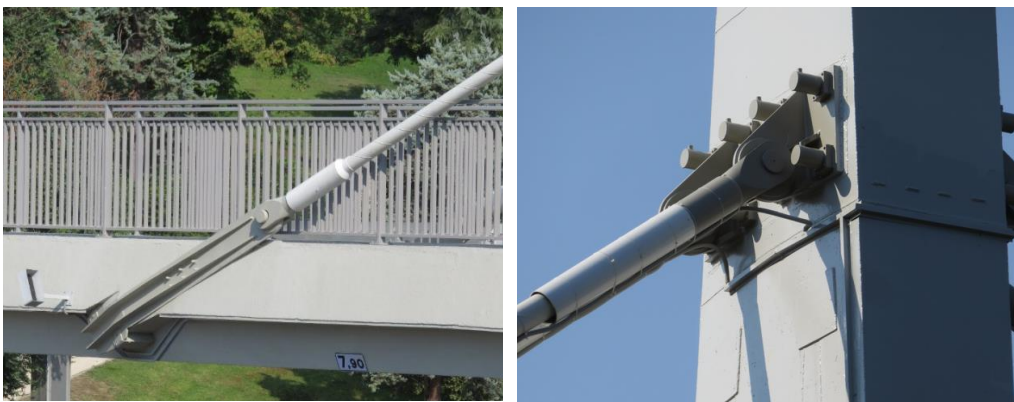
Significant design improvements were introduced at the interface between the cables and the structure. At the pylons, a lug-based connection system using prestressing bars enables force transfer while providing accessibility and allowing individual component replacement. At deck level, innovative connection details were developed to minimize intervention on the existing structure while ensuring direct load transfer and redundancy during the replacement process. For backstays, a new independent prestressed concrete anchoring beam was constructed to improve force distribution and durability.

*Figure 5: Modern cable layout and connection to the existing structure*
