## **OVERVIEW OF SCHOOL BUILDING CONDITIONS IN RURAL AREAS – LAZAREVAC MUNICIPALITY**

**Summary:** Rural primary schools within the Municipality of Lazarevac represent a significant portion of the public building stock. Most of the buildings are single-storey with load-bearing masonry systems, built in the second half of the 20<sup>th</sup> century according to the technical regulations of that period, which did not seismic resistance, durability, and energy efficiency. This paper reviews their key structural features, focusing on typical assemblies, materials, and operational deficiencies. The effects of the age, maintenance practices, and utilization level on structural performance are analyzed based on field surveys and condition assessment. The paper aims to identify predominant structural features and vulnerabilities of rural primary schools' masonry buildings, as well as to emphasize the need for a systematic approach to maintenance and rehabilitation within public infrastructure asset management.

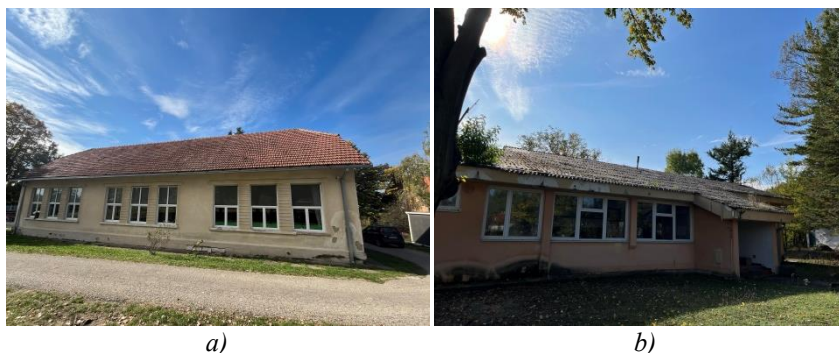
*Figure 1: a) School buildings in a village Arapovac build in 1930, and b) village Vrbovo build in 1960*

Analyzed buildings of a Municipality of Lazarevac (Figure 1.) were built in the period from the end of the 19<sup>th</sup> to the end of the 20<sup>th</sup> century, more precisely, they were built in the period between 1873 and 2000. The most of them were post WWII school buildings, built between 1950 and 1970, which was a period of rapid expansion of school network. To obtain building condition, functionality, and maintenance it was analyzed 10 rural primary schools, and 22 separate classes [19]. The primary focus of this study is on the structural condition of buildings. Many examined school buildings are single-storey, load-bearing masonry structures built with similar techniques and similar timeframe [19]. Based on available documentation analyzed rural schools are representing a school network of a Municipality of Lazarevac. Rural school buildings are mostly of small capacity, adopted to reduced number of students, with simpler architectural and structural design.

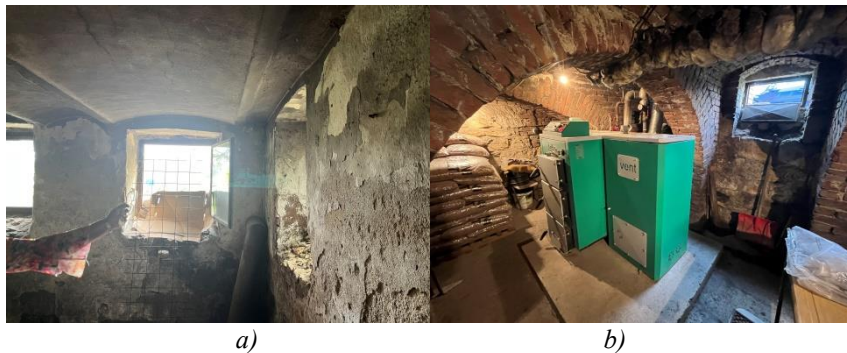
Figure 3: a) low brick vault School buildings in a village Krusevici, and b) pitched-brick vault in a village Mali Crljeni

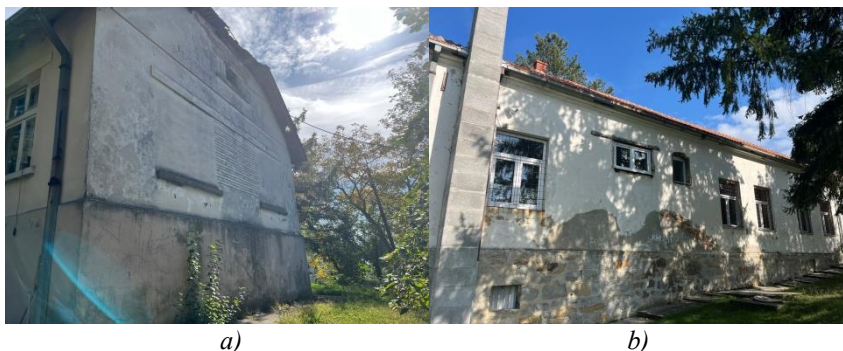
*Figure 6: General appearance and damages of a school building a) in village of Arapovac, and b) in village of Mirosaljci*

Field inspections of rural school buildings indicate that deteriorating roof structures and worn-out coverings are critical risks, often causing structural damage to the building as a whole. Based on observation nine buildings, leakage was primarily caused by deteriorated roofing materials, including rotten structures, broken tiles, and blocked gutter systems. Urgent roof reconstruction is required for four school buildings due to safety hazards, such as structural decay, that put students at risk. In one building asbestos-containing wave sheet roofing (ACR) poses a significant health hazard, as it releases toxic, airborne fibers, which further increases the risk and requires planned removal in accordance with environmental safety regulations. Most of the school buildings miss waterproofing which occurs capillary moisture (rising damp). Thermal insulation, in most school buildings in the rural areas of municipality of Lazarevac are without it, and the facades are mostly made of plaster with visible damage and moisture in the plinth areas. On some buildings plaster falling off, particularly on north-facing or wet sides, primarily caused by moisture ingress, dampness, and poor adhesion. Fenestration is combined, around 40% is PVC and more than 60% is old wood more than 30 years old. Poorly sealed and deformed windows and doors cause significant heat loss and interior moisture (condensation).

Dominant non-reinforced masonry (URM) buildings need a rehabilitation techniques for reconstruction, and they are key factors that affect the current state of these buildings. These measures, which often involve addressing poor quality mortar and adding structural ties, are crucial for adapting these structures to modern safety standards. A systematic approach to school infrastructure management is essential, ensuring safety by addressing structural integrity, functionality, and emergency readiness to protect students and staff.
