## **POST-FIRE ASSESSMENT AND REPAIR OF REINFORCED CONCRETE STRUCTURES: DAMAGE EVALUATION AND STRUCTURAL REHABILITATION**

A representative case study of post-fire structural assessment and rehabilitation is the residential building located in Skopje. On 1 December 2017, a fire occurred in the basement of the building and affected approximately one third of the basement area (Fig. 3). The affected space was used as a storage area containing combustible material with a high fire load. Due to the limited ventilation and the large amount of combustible material, the fire developed slowly and lasted for several hours. According to the temperature measurements recorded by the firefighters, temperatures exceeding 1000 °C were locally reached within the fire-affected zone. After the fire was extinguished, visible damage to several structural elements was observed, parts of the structure were temporarily supported, and the building was taken out of service.

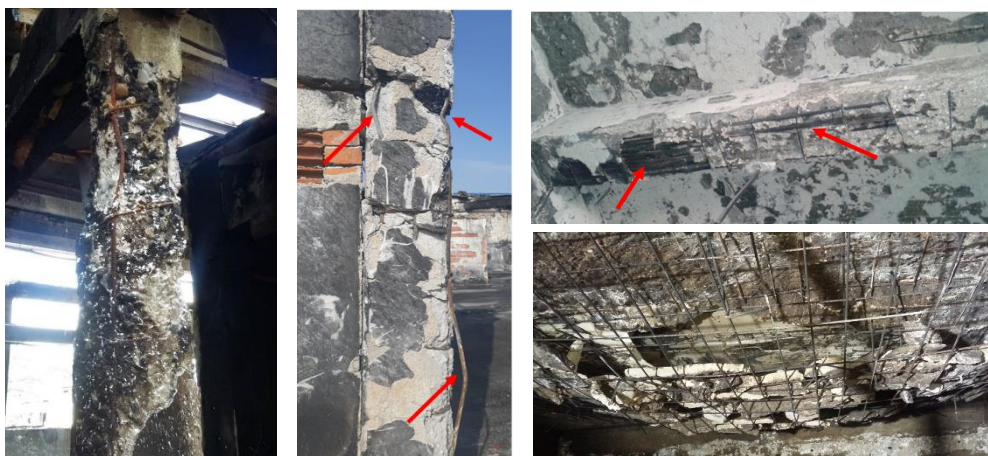
*Figure 1: Examples of fire-damaged RC structural elements*

Fire is one of the most severe accidental actions that can affect civil engineering structures. Unlike conventional mechanical loading, fire simultaneously modifies the thermal and mechanical properties of construction materials, leading to a progressive deterioration of structural performance. Reinforced concrete (RC) structures are generally considered to possess good fire resistance because concrete is a non-combustible material (Class A1) with relatively low thermal conductivity. Nevertheless, exposure to elevated temperatures causes significant changes in both concrete and reinforcing steel, resulting in reductions in stiffness, strength, and load-bearing capacity. Depending on the fire severity and duration, these changes may be accompanied by cracking, explosive spalling of the concrete cover, excessive deformations, reinforcement buckling, and, in extreme cases, partial or complete structural collapse (Fig. 1).

The structural response of reinforced concrete members during fire is therefore governed by the interaction between thermal gradients, material degradation, and mechanical loading. Depending on the fire scenario and structural configuration, the observed damage may include surface discoloration, cracking, delamination, spalling, reinforcement exposure, excessive deflections, and local or global collapse (Fig. 1).

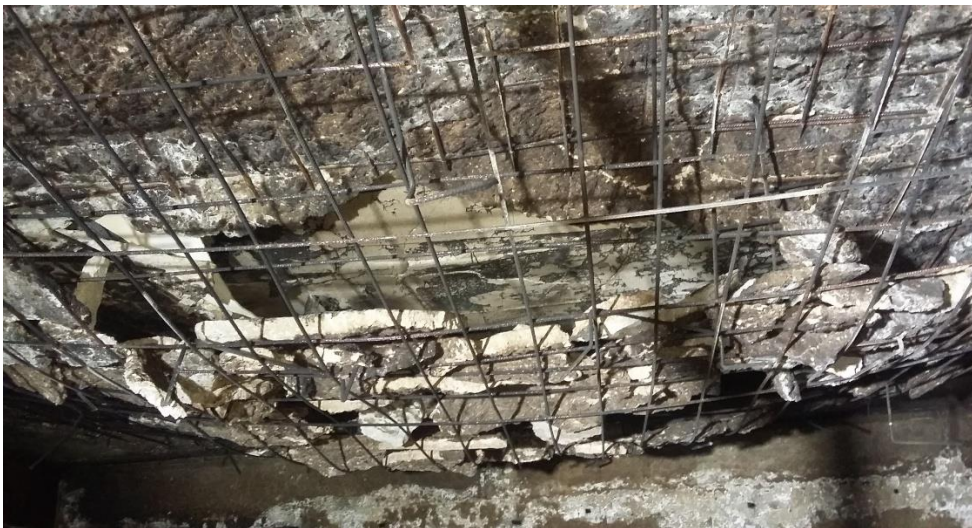
The first stage of the investigation consisted of a detailed visual inspection and documentation of the fire damage. Several different levels of damage were identified. The most severe damage was observed in one reinforced-concrete floor slab, where complete degradation of the concrete and collapse of the slab occurred (Fig. 4). In adjacent areas, extensive spalling of the concrete cover was observed (Fig. 5). Other elements showed changes in concrete colour, surface cracking, partial loss of the protective concrete layer and deposits of smoke and soot.

Figure 4: Complete degradation of the concrete and collapse of the RC floor slab between Axes 2 and 3

The severely damaged floor slab was removed and replaced with a new 14 cm thick reinforced-concrete slab. The existing reinforcement that remained suitable was incorporated into the new structural system, while additional reinforcement was provided in both directions.

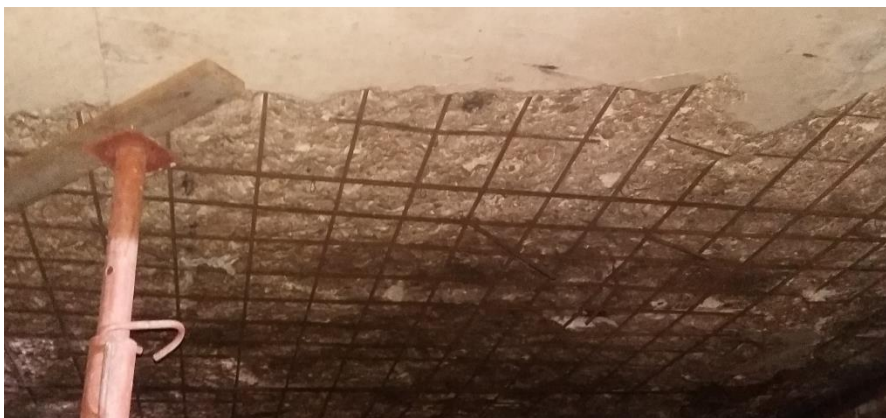
*Figure 5: Extensive spalling of the concrete cover of the RC floor slab between Axes 1 and 2*

For partially damaged slab areas, the degraded concrete cover was removed, anchors and additional reinforcement were installed, and a new concrete layer was applied using shotcrete. Similar rehabilitation was specified for the damaged basement reinforced-concrete walls.

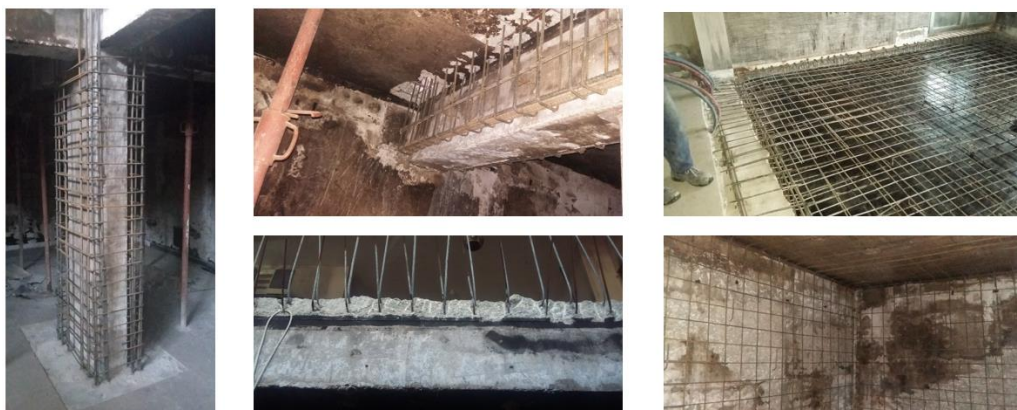
Based on the combined visual inspection, measurements and thermal-structural analysis, a targeted rehabilitation strategy was selected rather than complete demolition of the structure. Elements with severe and clearly visible damage were assigned complete replacement, while elements with residual capacity were rehabilitated or strengthened (Fig.7).

Figure 7: Repair and strengthening of fire damaged RC structural elements

The columns C2 and C3 were strengthened by increasing their cross-sectional dimensions and adding new reinforcement. The existing columns were enlarged with a new reinforced-concrete layer, while the connection with the existing foundation was achieved using anchored reinforcement.

The damaged beams were rehabilitated by increasing their cross-section on three sides. New reinforced-concrete portions were added parallel to the existing beams and connected to the existing structure using anchors and stirrups. Following the strengthening, the beam cross-section was increased to approximately 50/55 cm.
