### **STATIC TENSILE FACTORY ACCEPTANCE TESTING OF THE OVM.ST15-47 PARALLEL-STRAND HANGER SYSTEM FOR THE NEW SAVA BRIDGE IN BELGRADE, SERBIA**

**Summary:** This paper presents the full-scale static tensile factory acceptance testing of the OVM.ST15-47 parallel-strand hanger system intended for installation on the New Sava Bridge in Belgrade, Serbia. Each tested hanger assembly consisted of 47 seven-wire prestressing strands, with a nominal tensile strength of 1,860 MPa and a nominal cross-sectional area of 150 mm<sup>2</sup> per strand, together with the associated anchorage and fork components. Two representative full-scale hanger specimens were subjected to a predefined staged loading procedure, including a 60-minute load-holding period at 0.8 of the guaranteed ultimate tensile strength (GUTS), followed by loading to the governing acceptance force. The required acceptance force was defined as the greater of 95% GUTS and 92% of the calculated actual ultimate tensile strength (AUTS) of the 47-strand bundle. Both specimens exceeded the governing force and minimum elongation requirements. No damage to specimens and no failure of anchorage-system components were observed after the lo

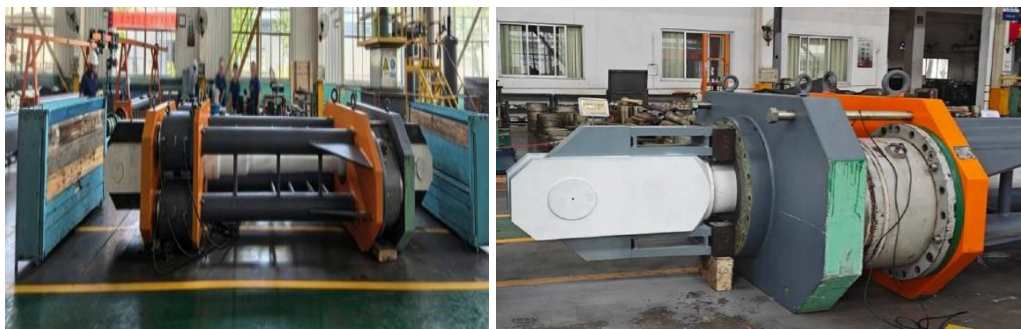
Figure 9: Full-scale static tensile test arrangement: fixed-end anchorage (left) and longitudinal view of the assembled hanger specimen (right)

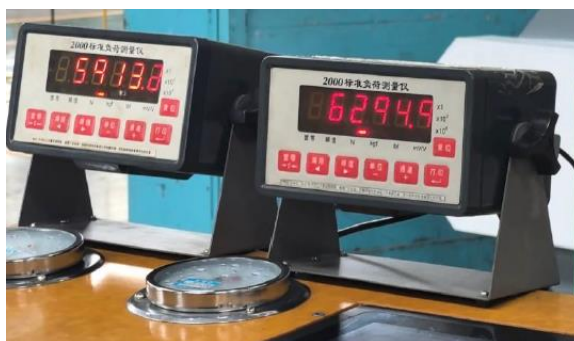
Figure 10: Digital force indicators used for monitoring the applied tensile load

The applied tensile force was monitored using calibrated LC-3/20 MN dynamometers connected to digital force indicators. The dynamometers had a nominal measuring capacity of 20 MN and were covered by calibration certificates LSfm2025-02593 and LSfm2025-02914 issued by the National Institute of Metrology, China (2025). The reported relative measurement uncertainty was 0.3%, providing an appropriate level of accuracy for verifying attainment of the governing acceptance force.

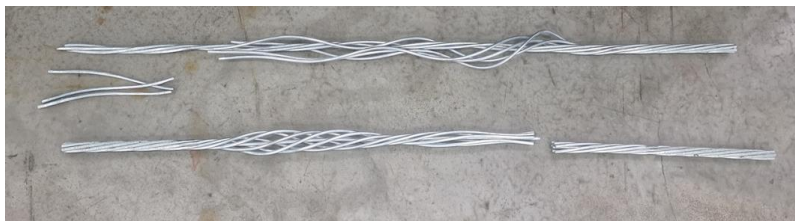
*Figure 11: Individual strand specimen after tensile testing, showing characteristic wire fractures*

The individual strand specimens used to determine the average actual ultimate tensile force were tested separately to rupture. These tests produced characteristic wire fractures and provided the experimental material basis for calculating AUTS. The fractured individual strand shown in Figure 11 should therefore be distinguished from the two full-scale hanger specimens, neither of which was tested to failure.

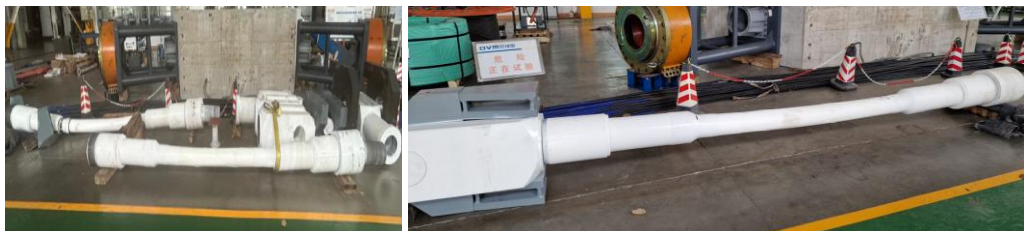
*Figure 12: Post-test inspection of the hanger specimens and anchorage assemblies*

No damage was identified in either full-scale specimen, and no failure occurred in any component of the anchorage system. The sockets and fork-type connections remained intact, and no visible evidence of unacceptable deformation, cracking, fracture, strand slippage, or loss of anchorage integrity was reported (Liuzhou OVM Structure Monitoring Technology Co., Ltd., 2026b; Bureau Veritas, Industry & Facilities Division, 2026).
