Vlastimir Radonjanin<sup>1</sup>, Mirjana Malešev<sup>2</sup>

## **BEFORE ANY INTERVENTION: THE CHALLENGE OF STRUCTURAL ASSESSMENT**

**Summary:** Before any strengthening, repair, reconstruction or adaptation of an existing structure can begin, engineers face one of the most demanding tasks in practice: establishing its true condition. Structural assessment is far more than a routine inspection - it is an investigative process combining field observation, testing, material science, structural analysis and engineering judgement to interpret incomplete or hidden evidence. The reliability of every subsequent intervention depends directly on how accurately this initial step is performed. The paper discusses why structural assessment is inherently complex, what makes it demanding in practice, and why it represents the foundation of every informed engineering decision on existing structures, illustrated through practical examples from bridges, buildings and other engineering structures.

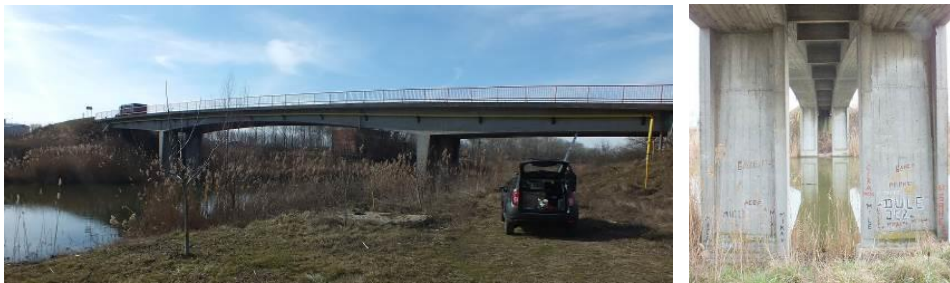
**Example 1:** The road bridge over the DTD canal has been in use for road traffic since 1961. The bridge is a prestressed-concrete, three-span continuous girder structure, with spans of 17 m + 41 m + 17 m. A visual inspection of the bridge from the outside gave no indication whatsoever of the critical condition of the structure.

Figure 1: General view of the road bridge over the DTD canal

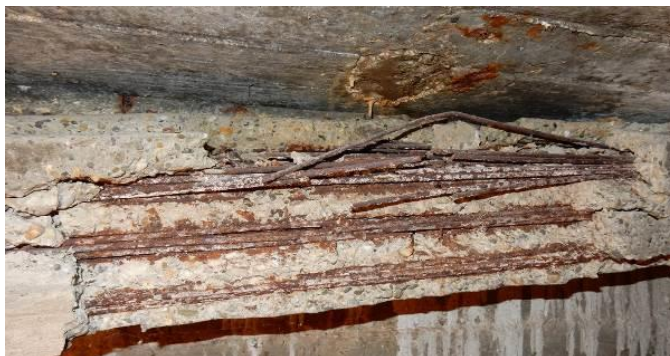
However, after entering the box girders through a narrow opening in the bottom slab and working our way through openings in the cross-diaphragms, we discovered that the bridge was, quite literally, one step away from total collapse! Based on this finding, traffic on the bridge was restricted immediately, and a repair design was prepared which included the complete replacement of the prestressing tendons.

Figure 3: Broken wires in the upper row of the prestressing tendon on axis B, damp stains and traces of rust around the openings used for the subsequent concreting of the tendon

The essence of the problem with this and similar bridges is that the most critical elements of the bridge structure, the prestressing tendons, remain effectively “hidden” inside the box girders for the structure's entire service life, meaning that routine inspections from the outside alone can lead to catastrophic consequences.

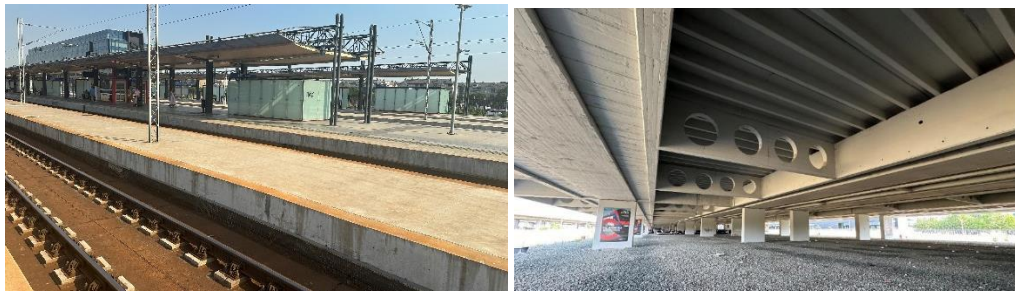
**Example 2:** After several months of searching, we found parts of old archival design documents, including the report of the technical acceptance commission, which cast an entirely different light on the structure of the railway bridge at Novi Beograd. This continuous, prestressed reinforced-concrete bridge carries 5 tracks and, until two years ago, when we carried out the condition assessment and repair, had been in service for 55 years. The bridge is 474 m long overall and 56 m wide.

Figure 4: General view of the railway bridge at Novi Beograd, from above and below

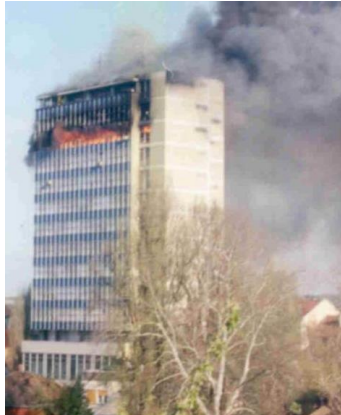
**Example 3:** On 6 April 2000, a fire broke out in the building of the Novi Sad Open University. The fire started on the 12th floor and very quickly spread in both vertical directions to the top six floors of the building (floors 8–13). As a result of the fire, the load-bearing structure of the building was damaged, and the façade, interior finishes and installations on the affected floors were partially or completely destroyed.

Figure 6: 11th floor affected by the fire

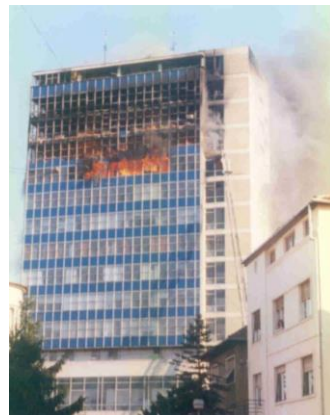
Figure 7: 9th floor affected by the fire

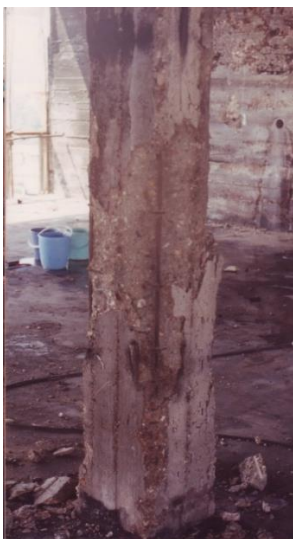
The search for documentation took a full five months. By the time we had almost completed the condition assessment and the structural check calculation, the most persistent member of our team managed to locate a large part of the original design documentation. In addition to all the characteristic fire damage to the concrete and reinforcement, on this building we identified, for the first time, another form of “hidden” damage. This was internal delamination, a crack within the interior of the cross-section, located at a depth of approximately 10 cm from the surface, which we subsequently detected regularly inside the fire-affected reinforced-concrete columns.

Figure 8: Crack within the concrete of RC columns affected by the fire

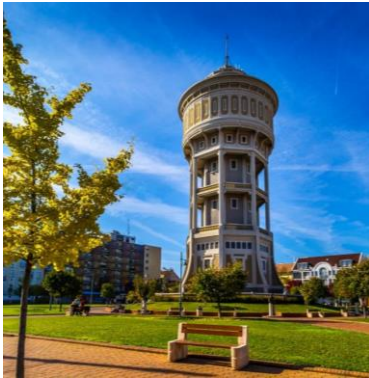
**Example 4:** The water tower in Beočin is a masterpiece of civil engineering, and even of architecture, in the field of reinforced-concrete structures from the late 19th century. For our team, this structure was a major challenge, since at the outset we had not a single piece of data on the structure available to us. We learned that it had been designed by the Hungarian engineer Szilárd Zielinski, and later discovered that he had also designed the water tower in Szeged as the subject of his doctoral thesis, the first reinforced-concrete structure ever built in Hungary.

*Figure 9: The first water tower built of reinforced concrete in Hungary (1904, Szeged, Hungary)*

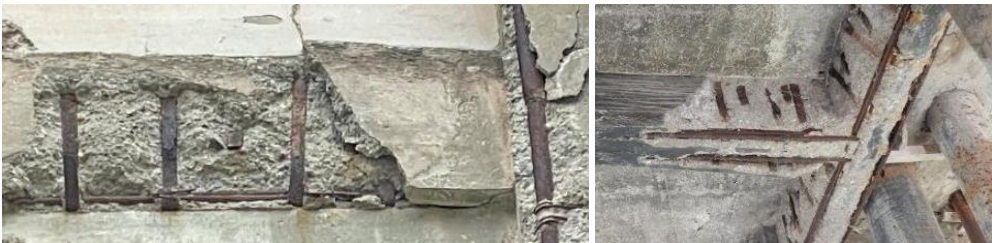
This comparison helped us understand the design concept the engineer had applied to these structures. During extensive investigations, which lasted almost a year, we discovered that flat steel bars had been used as stirrups, and we came across some of the earliest connectors used for lapping reinforcement bars.

*Figure 12: Use of flat steel bars as stirrups in RC beams*

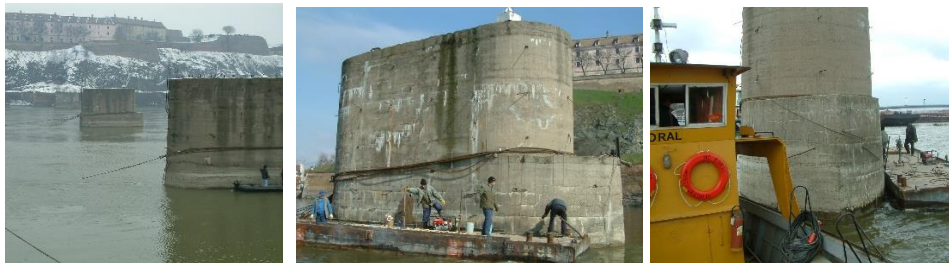
**Example 5:** The remaining piers of the old bridge over the Danube in Novi Sad, presented a new challenge. Underwater cameras failed to produce usable results, so, in the middle of winter, we engaged professional divers, trained them for the task, and carried out an underwater survey of the massive piers and foundations.

*Figure 13: Use of boats and barges to prepare for the inspection of the piers*

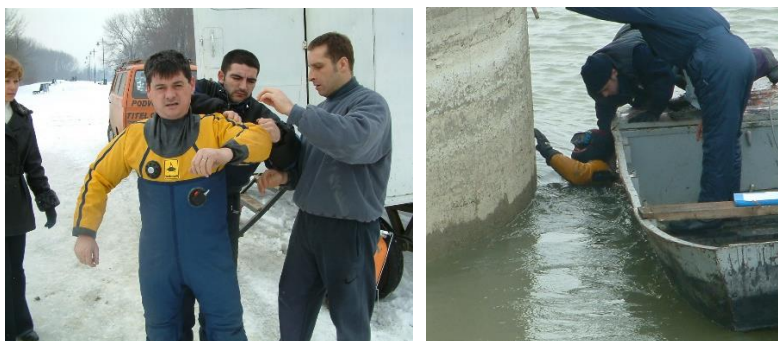
*Figure 14: Diver preparing to be lowered into the Danube*
