THE COLLAPSE OF THE CAROLABRIDGE – A TRAGIC INDIVIDUAL CASE?

Keywords: stress corrosion cracking, prestressed concrete bridge, collapse

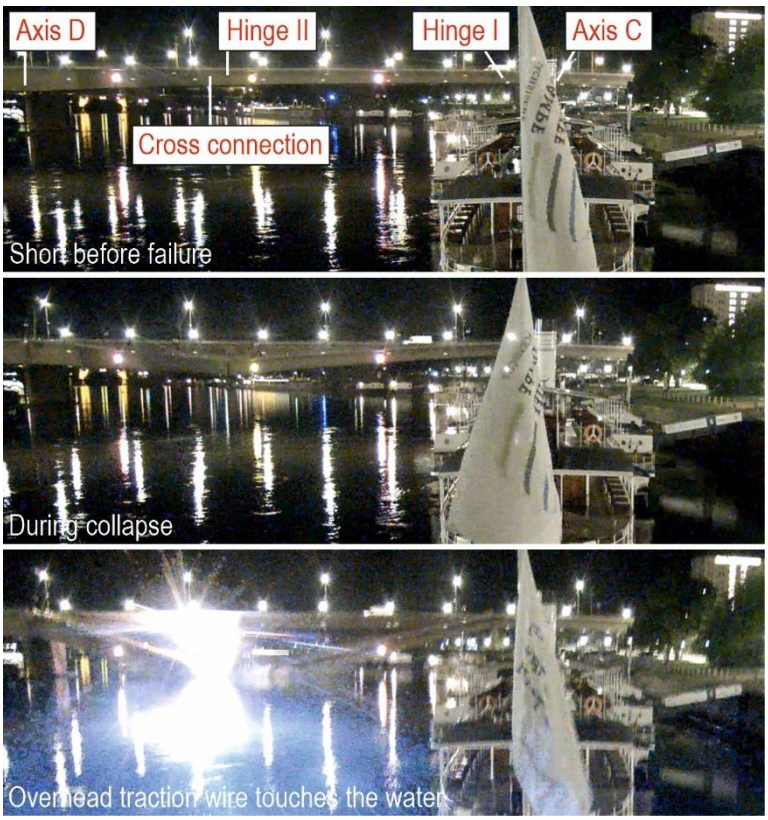
dramatic event (Figure 2). Looking upstream, it captured exactly the critical area between axes C and D. A frame-by-frame analysis showed the collapse process: first, the area of hinge II began to sink, while a crack opened up at the support cross-section of axis D. Shortly thereafter, the contact wire came into contact with the water. A flash of lightning illuminated the darkness, accompanied by a spraying fountain. Only about eight minutes before the failure, a tram had rolled over this very bridge and most likely initiated the kinematic chain. Fortunately, there were no pedestrians or cyclists on the structure at the time of the collapse.

Figure 2: Recordings from a surveillance camera: initial state and moment of collapse (video from Saxon Steamship Company,[18])

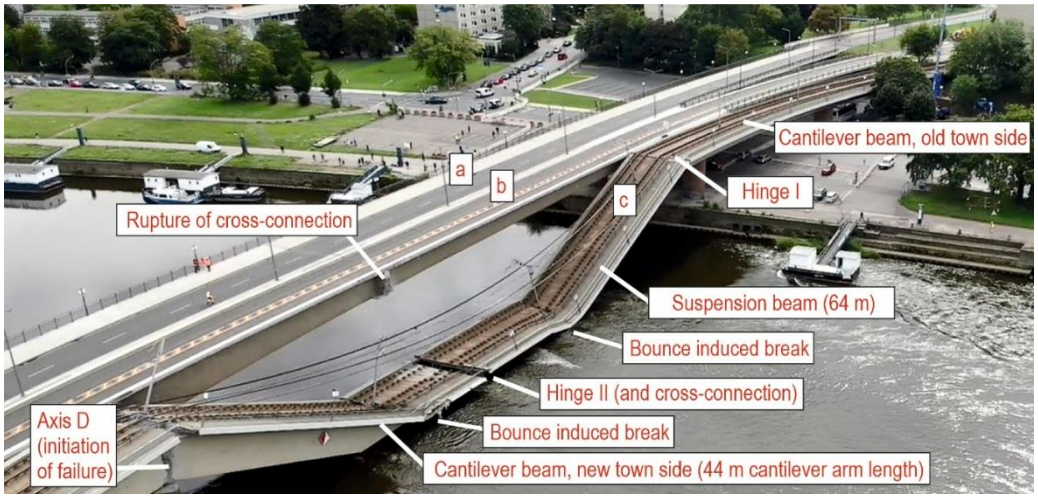
At daylight, the extent of the damage became apparent (Figure 3). A state of emergency had already been declared, and the City of Dresden, the fire department, the Federal Agency for Technical Relief (THW), the police, and the German Armed Forces set up a crisis management team at the abutment on the old town side. The responsible road and civil engineering office convened a group of experts who first assessed the acute stability of the still standing superstructures a and b. A look at the torn-open cross-section in axis D of superstructure c immediately provided clues as to the cause of the damage. Just a few hours after the accident, technical documentation of the damage began – initially using drones, and later with photographs taken from the neighboring superstructure b.

Figure 3: Carola Bridge immediately after the collapse of superstructure c (© MKP GmbH, [16][16, mod.)

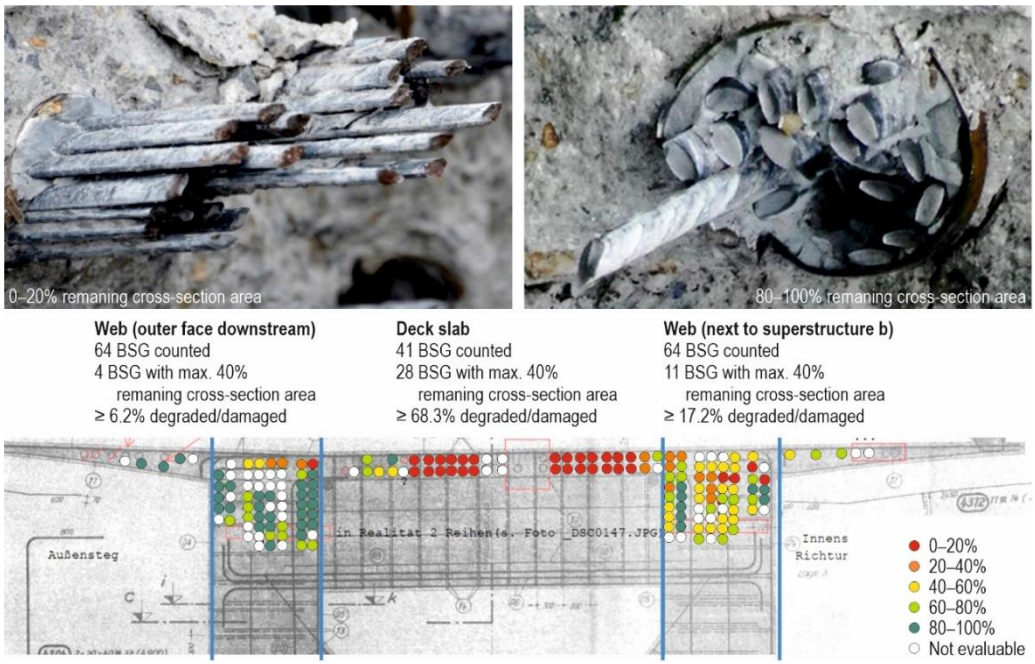
The condition of the prestressed wires was visually assessed and categorized. It was clearly visible that the deck slab tendons, which remained partially tensioned in the ducts during manufacturing of the suspension beams (see chapter 2), showed particularly severe pre-damage and dark corrosion on the fracture surfaces (top left photo in Figure 4). Obviously, these wires had been broken for quite some time. Fresh fracture surfaces (top right photo in Figure 4), mainly on web tendons, were metallically shiny with no signs of corrosion, but also without any ductile deformation in the form of necking in the fracture area. In some cases, tendons with visible necking were also found, indicating ductile failure.

Figure 4: Results of photographic documentation of the condition of the prestressing wires, broken cross-section in axis D, superstructure c, view towards Dresden new town (© MKP GmbH,[16], [19])

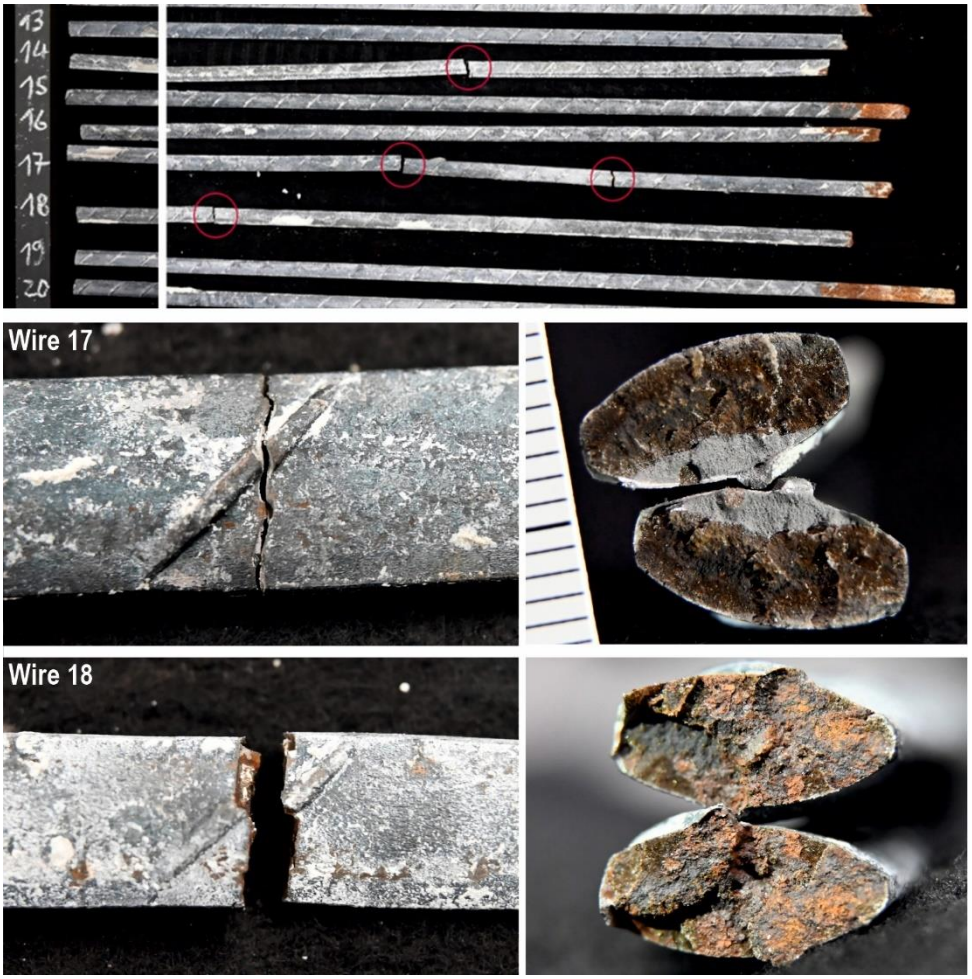
The samples obtained were first documented photographically in the laboratory and then subjected to further material tests. In some of the tendon sections taken from the area of the fracture, wire breaks were already detected when the tendon was opened (Figure 5, top). In some cases, cracks were even visible to the naked eye. Many fracture surfaces showed clear signs of corrosion (wires 17 and 18 in Figure 5). It should also be noted that prestressing wires with multiple fractures and a distance of less than 15 cm were found (see wire 17 in Figure 5). This indicates an immediate re-anchoring length of a few centimeters after a break.

Figure 5: Breaks of wires from a tendon extracted from the failure area in axis D of superstructure c (top) and details of the breaks of the wire 17 and 18 (below) (photos: MKP GmbH,[18])

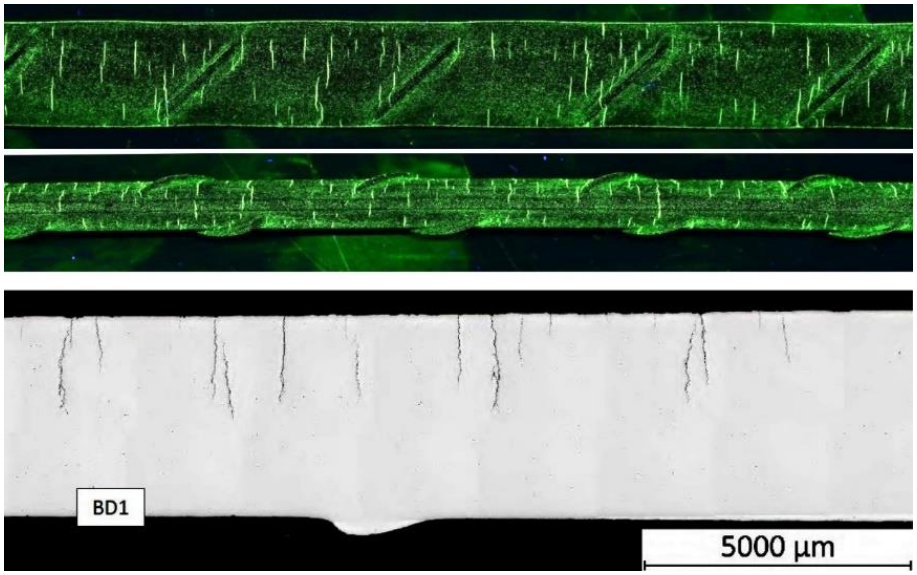
For further analysis, crack detection tests with magnetic powder, microscopic examinations of the fracture surfaces, microstructural examinations and examinations of the alloy composition carried out at the Federal Institute for Materials Research and Testing (Bundesanstalt für Materialforschung und -prüfung – BAM), Berlin. Magnetic particle inspection (MPI) tests, cracks or material defects on the surface or close to it can be made visible under UV light using fluorescent magnetic powder particles. The top photo in Figure 6 shows a prestressing wire during MOI investigation with a large number of initial cracks, which can be clearly attributed to SCC. Figure 6 below shows a longitudinal section of a prestressing wire where the typical cracks are also clearly visible.

Figure 6: Initial crack detection using fluorescent magnetic powder (top) and longitudinal sectioning (bottom) of two prestressing wires taken from the Carola Bridge (photos: BAM Berlin, [16])
