## REHABILITATION OF O'HARE INTERNATIONAL AIRPORT PARKING STRUCTURE

**Summary:** The primary parking structure serving O'Hare International Airport was opened for use in 1973 with 10,000 parking spaces and over 240,000 square meters of supported slabs. The six-story concrete structure was primarily reinforced using button-head post-tensioning. A condition assessment was performed in January of 2018 and identified structural deterioration which included freeze-thaw deterioration of concrete, corrosion-related delamination and spalling, and localized eruption of failed button-head tendons. Waterproofing deterioration consisted primarily of wear of waterproofing membranes and damage and wear of expansion joint seals. The resulting multi-year restoration program to extend the service life of the parking structure began in September 2020 and was completed in September 2022. Concrete and post-tensioning repairs to the slab, beams, girders, and columns were performed throughout. Sealant and expansion joint seal replacement were also performed to address leaks. Additionally, a unique structural strengthening repair was implemented at one of the columns that supports a signature helical ra

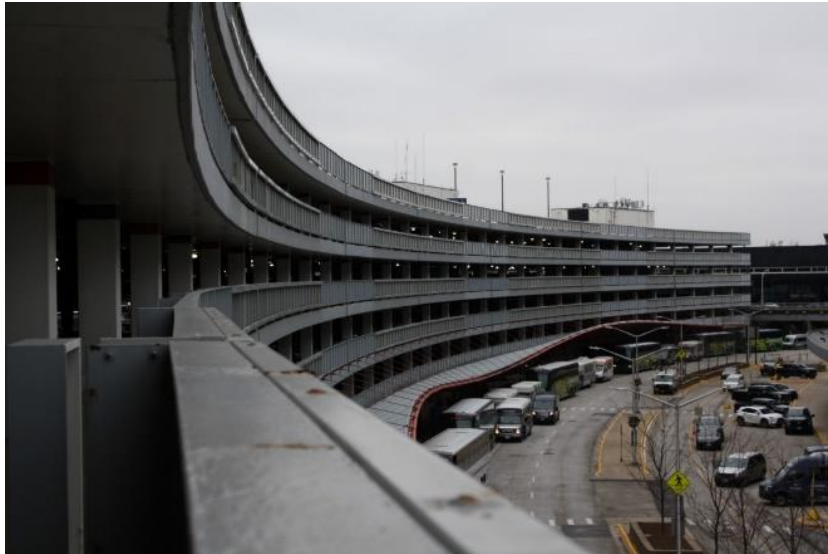
The elevated parking structure at O'Hare International Airport is a six-story structure (Figure 1) that was designed by C.F. Murphy Associates of Chicago, Illinois in 1968 and opened for use in 1973. The structure is located on the north side of the airport terminals, and extends between the stations for the automated transit system (ATS) at Terminal 1 on the west and at Terminal 3 on the east. In plan view, the parking structure is shaped like an arch between these two terminals for a length of approximately 325 meters along the southernmost column line and 435 meters along the northernmost column line. Along the north-south column lines, the structure is 140 meters wide. Four pairs of spiral ramps are located in the center of the garage that allow vehicular access to all levels.

*Figure 1: Overall view of the south elevation of the elevated parking structure*

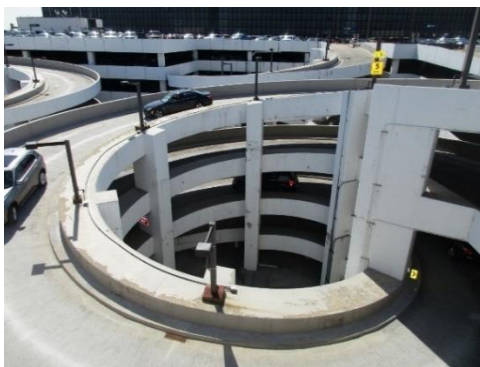
Each pair of spiral ramps is essentially an independent structure, isolated from the garage (Figure 8). The ramps are constructed by cantilevering four levels of sloped floor slabs from six central columns. A bonded overlay was installed over the structural ramp slab during a previous repair project. The ramps receive heavy applications of deicing salts, and no traffic coating was present. Untreated cracks and debonded overlay allowed chloride and moisture exposure to the embedded reinforcement, leading to concrete deterioration, especially at the joint between the ramps and the parking deck (Figure 9). The deterioration at the joints required shoring of the slab during reconstruction of the joint where the bearing plate was cleaned and coated with corrosion-inhibiting coating and reinforcement with complete section loss was replaced with new epoxy-coated reinforcement. Over 1,100 square meters of concrete repairs on the top surface of the ramp slabs was performed with an additional 950 square meters of concrete repair on the underside of the ramps.

*Figure 8: Helical ramp structure*
