## THE COLLAPSE OF THE CAROLABRIDGE – A TRAGIC INDIVIDUAL CASE?

**Summary:** The majority of small and medium-span bridges in Germany are made of prestressed concrete. All bridges are inspected at regular intervals to identify damage or load-bearing deficiencies at an early stage. Nevertheless, on September 11, 2024, the prestressed Carola Bridge in Dresden partially collapsed without prior warning. This article first provides an overview of the bridge inventory in Germany and the normative regulations governing their monitoring. It then presents the special design of the Carola Bridge and its construction. The main part focusses on the search for the causes of the failure and an attempt to reconstruct the sequence of events leading to the collapse. The article concludes with an outlook on issues relating to the future handling of bridges containing prestressing steel that is susceptible to hydrogen induced stress corrosion cracking (SCC).

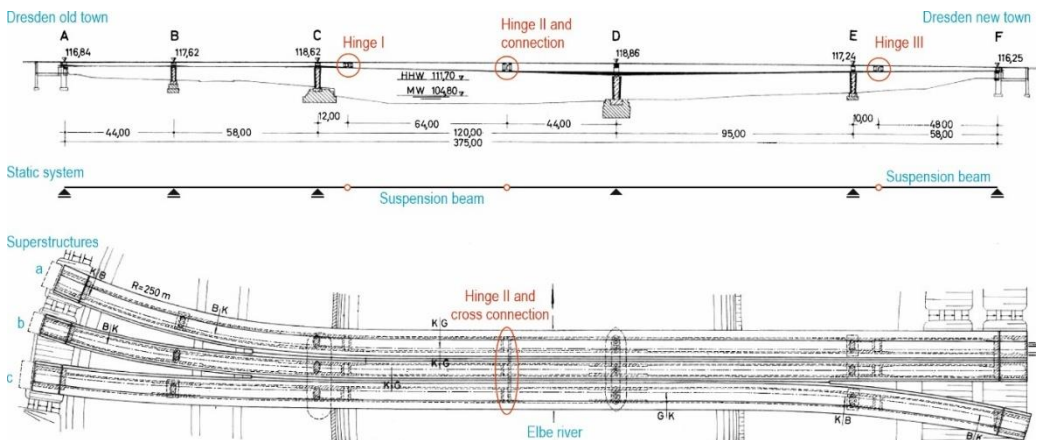
was chosen: each superstructure was subdivided by a total of three hinges (see sketch in the middle of Figure 1). This resulted in a two-span girder cantilevering 12 m towards the Elbe river in axes A–C on the Dresden old town bank. Supports D and E carry a single-span girder with two cantilevers – 44 m long towards the Elbe and 10 m long towards Dresden new town. Hinges I to III were arranged at the ends of the cantilever arms. A 64 m long suspension beam bridged the gap between the cantilever arms. An additional suspension beam was placed in the edge span on the new town side. The fixed point was located at the pier in axis D. Here, the superstructure had a maximum construction height of 5.2 m.

Figure 1: Longitudinal section, static system and ground plan of the Carola Bridge, left: Dresden old town, right: Dresden new town (technical drawings from [12], mod. by Silke Scheerer)
