## OPERATION AND MAINTENANCE OF BRIDGE DRAINAGE SYSTEMS ALONG THE SAVA RIVER IN BELGRADE

**Summary:** This paper assesses the operational performance of drainage systems on four road bridges over the Sava River in Belgrade: Branko's, Gazela, Ada Ciganlija, and Ostružnica. Field inspections identified deficiencies related to original design, subsequent modifications, ageing drainage infrastructure, structural and pavement deformations, and inadequate maintenance, all of which can significantly reduce drainage effectiveness. Particular attention is given to the Gazela Bridge, where hydraulic analysis showed that an average structural deflection of 14 cm reduces flow velocities in drainage pipes by about 10% for the 10-year design storm, increasing the potential for sediment deposition and pipe blockage. The four cases demonstrate that drainage functionality can be compromised at different stages of the bridge life cycle. The paper highlights the need for continuous inspection of structural and drainage components and performance-based maintenance.

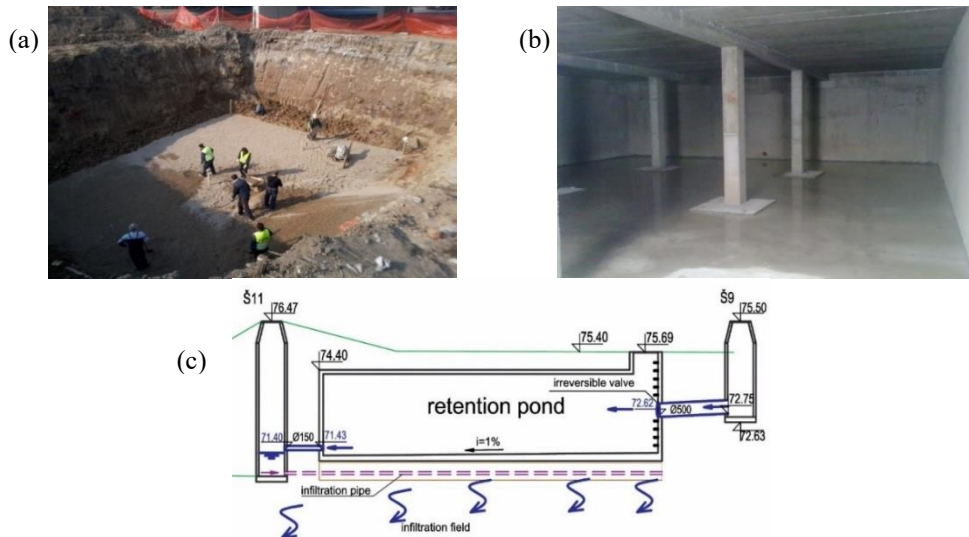
Figure 10: Retention pond as a receiving body for the Gazela Bridge drainage system: (a) during construction, (b) during operation, and (c) cross section showing redirection to the sewer system and the infiltration system [15]
